# Inspection Report

**Property Address:**  
2280 Fallen Crest Way  
Buford GA 30518

**Dana Inspection Services, Inc.**

| <b>Date:</b> 1/13/2021 | | |

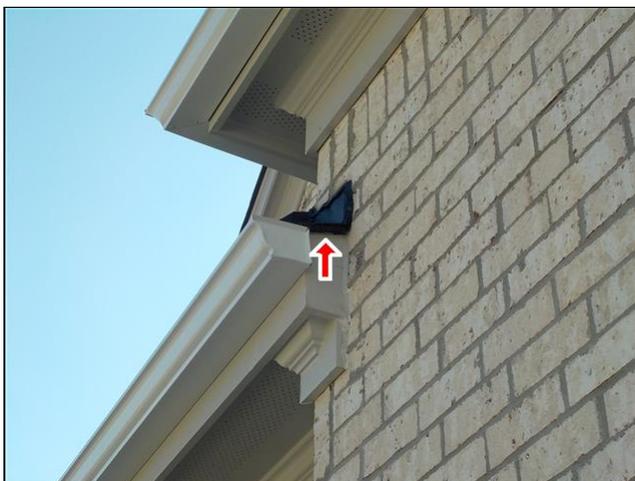
### 1.4 **DRIP EDGE (R905.2.8.5)**

- 1 A drip edge is missing at a small rake edge above the left hand garage opening.

A drip edge is missing at a small rake edge above the left hand garage opening.

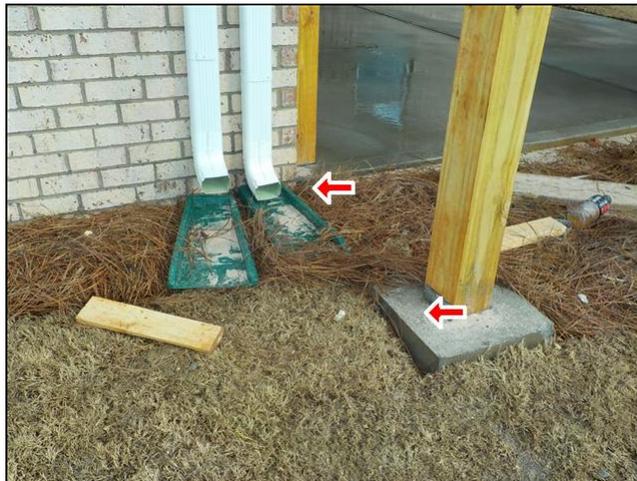
### 1.11 **GUTTERS**

- 1 An extension should be added at one or both of the downspouts under part of the deck where one of them will be draining onto the footing for the deck post.

An extension should be added at one or both of the downspouts under part of the deck where one of them will be draining onto the footing for the deck post.

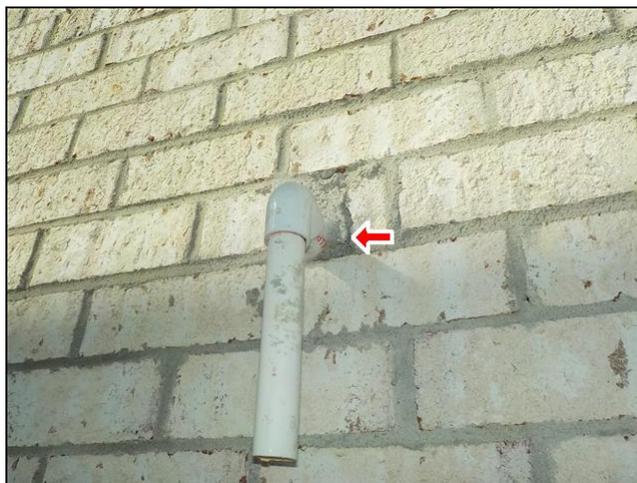
**2.1 GEORGIA INSULATION INSTALLATION (APPENDIX RA) \*\*Includes exterior penetrations**

- 1 One of the higher up drain pipes on the exterior left needs its penetration sealed better sealed.

One of the higher up drain pipes on the exterior left needs its penetration sealed better sealed.

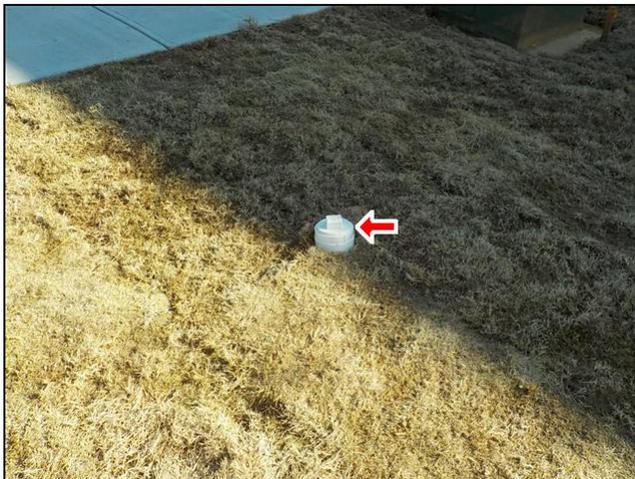
**2.5 \*\*DRAINAGE PIPE CLEANOUTS (IPC 708.1.2 & 3 GA AMEND 2020) 10' of street & outside near house**

- 2 The front yard cleanout should be recessed in a box that is flush with the ground.

The front yard cleanout should be recessed in a box that is flush with the ground.

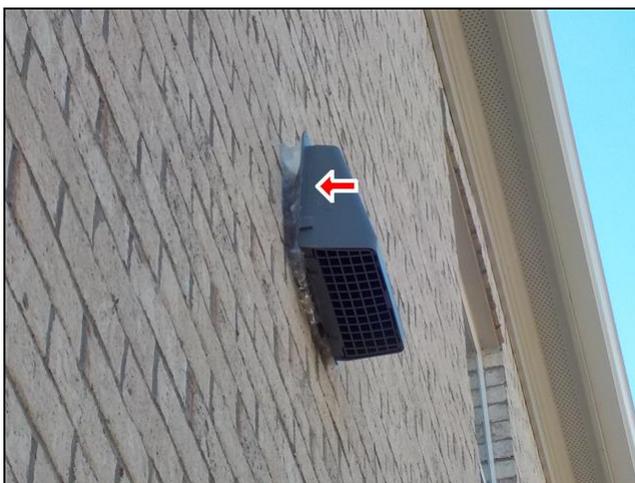
**2.11 PROTECTION OF EXHAUST VENTS (IRC R303.6)**

- 3 The exterior hood for the kitchen vent was not installed in a professional manner as it is not tight to the house. This has caused the excessive need of caulking that is already not sealing well.

The exterior hood for the kitchen vent was not installed in a professional manner as it is not tight to the house. This has caused the excessive need of caulking that is already not sealing well.

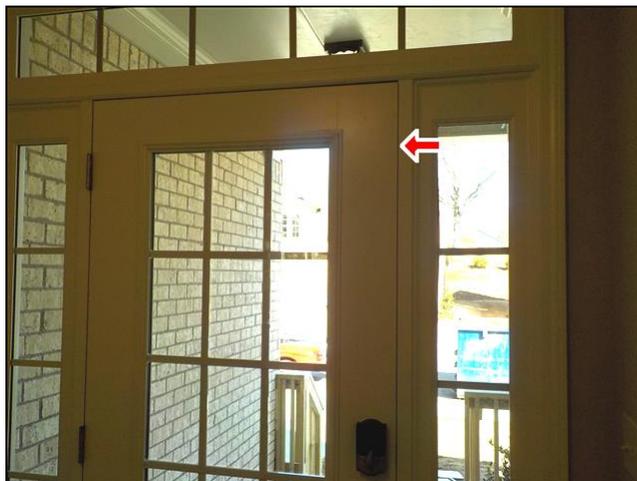
**2.12 EXTERIOR DOORS AND WINDOWS**

- 4 The front door knocks against the door frame when closed.

The front door knocks against the door frame when closed.

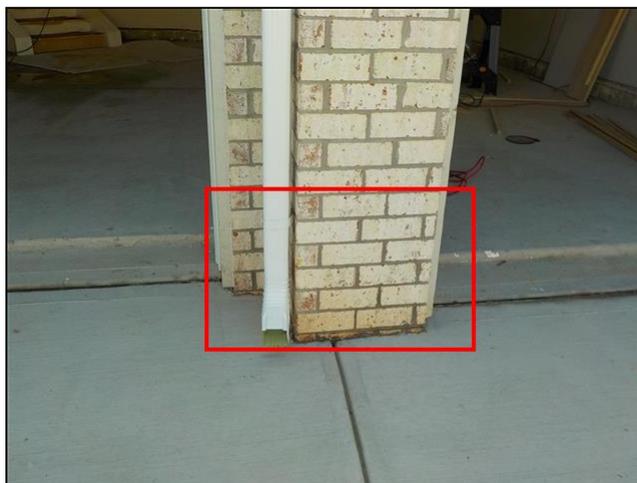
- 2 (1) I was unable to locate weep holes in the wall base of the brick veneer between the garage openings.

(1) I was unable to locate weep holes in the wall base of the brick veneer between the garage openings.

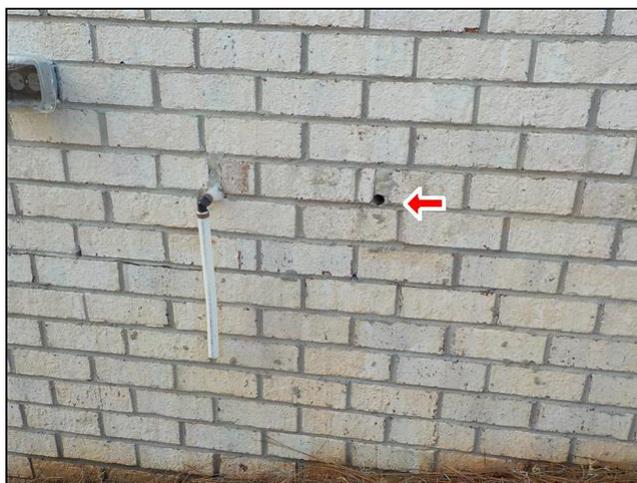
- 5 (2) A hole was observed in the brick at the exterior left toward the front.

(2) A hole was observed in the brick at the exterior left toward the front.

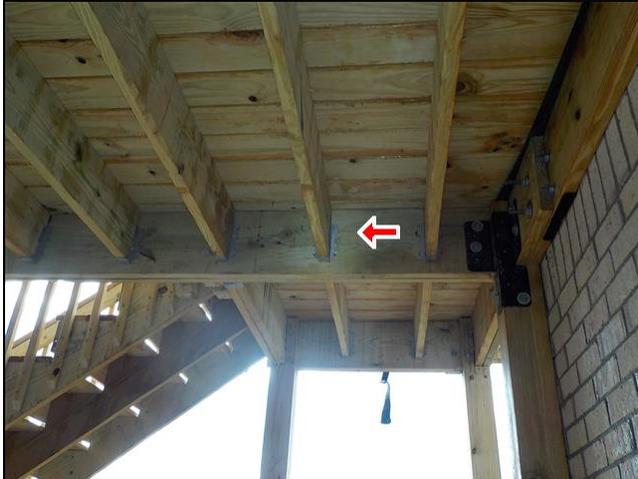
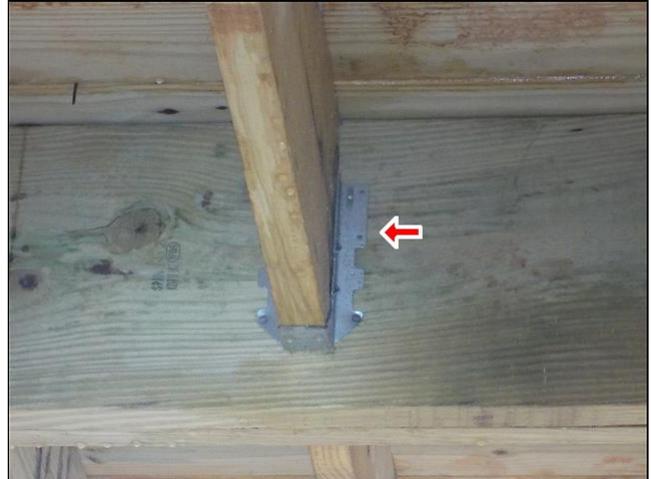
**3.0 JOIST HANGERS (MANUFACTURER)**

- 3 One of the deck joist hangers near the underside of the top landing of the deck stairs is missing some fasteners.

One of the deck joist hangers near the underside of the top landing of the deck stairs is missing some fasteners.

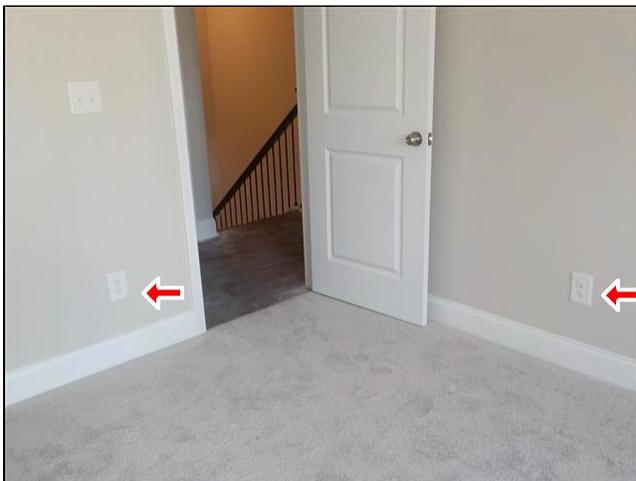
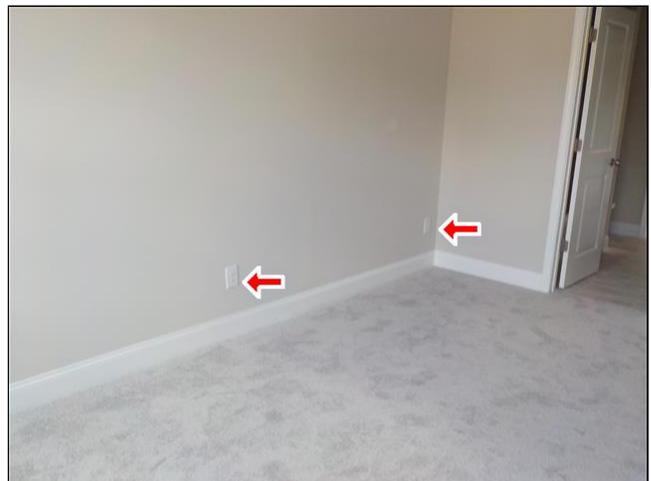
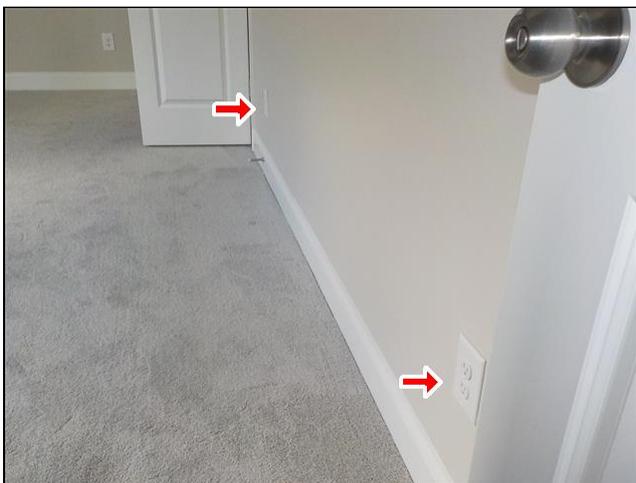
**4.1 WORKMANSHIP (110.12)**

- 4 Many outlets in 2nd floor bedrooms are loose. All 2nd floor outlets should be evaluated and secured where needed.

Many outlets in 2nd floor bedrooms are loose. All 2nd floor outlets should be evaluated and secured where needed.

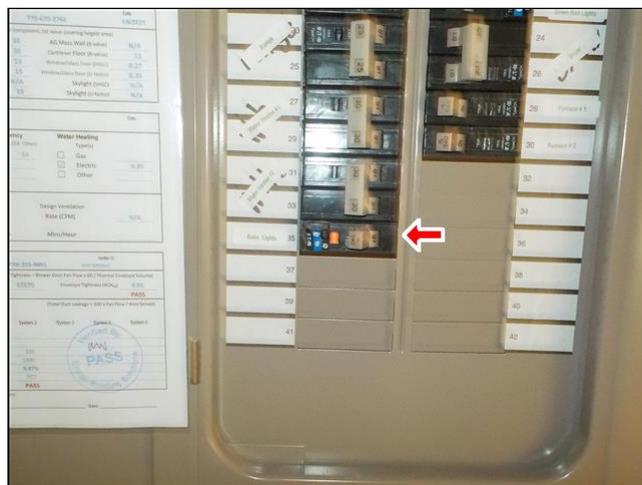
**4.9 ARC FAULT PROTECTION WHERE REQUIRED & OPERATION (210.12)**

- 5 The basement lights circuit breaker is tripped but does not reset.

The basement lights circuit breaker is tripped but does not reset.

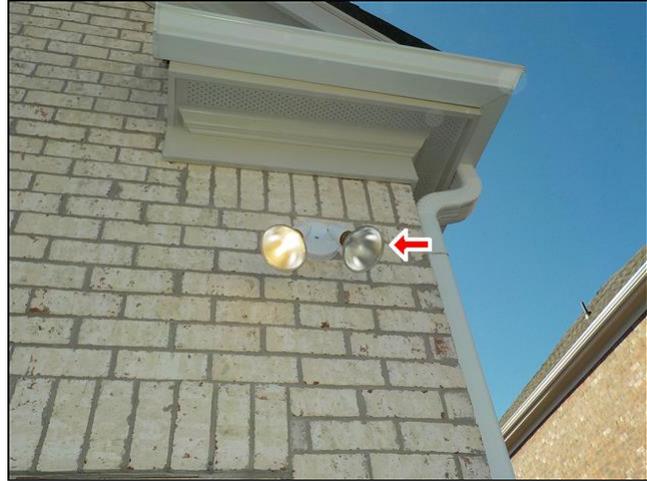
(1) The front flood light has a burnt out bulb.

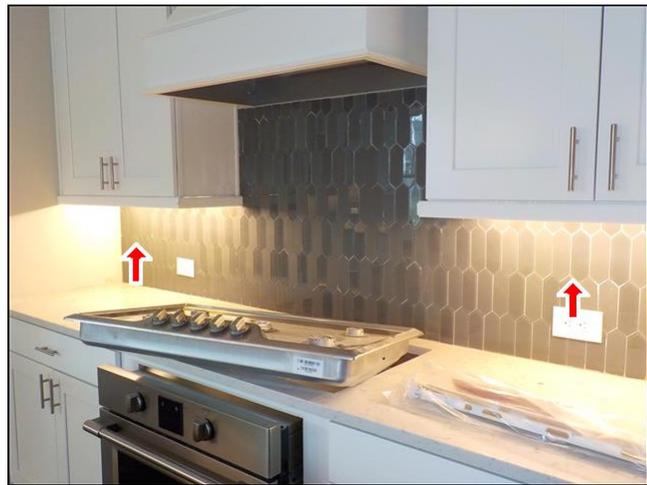
(2) The undermount kitchen lights blink periodically.

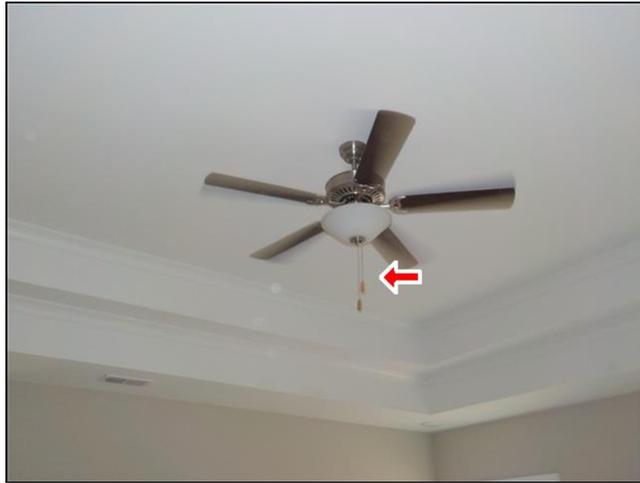
- 8 The master ceiling fan pull chain needs an extension to be able to control the fan speed. Have other fans evaluated for use as well and extensions added where needed.

The master ceiling fan pull chain needs an extension to be able to control the fan speed. Have other fans evaluated for use as well and extensions added where needed.

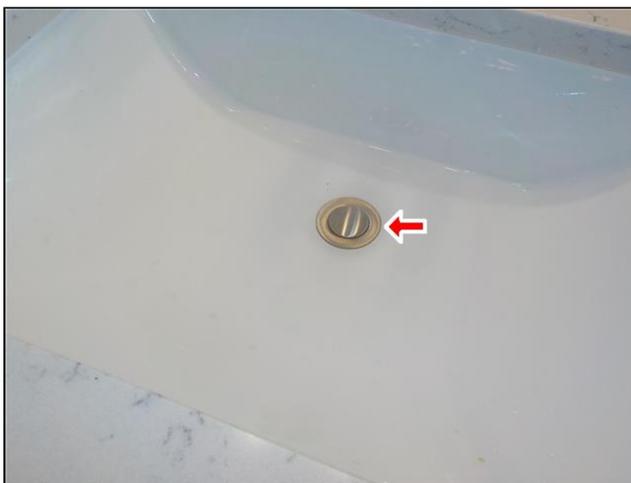
(1) The left hand master sink stopper does not make a complete water seal.

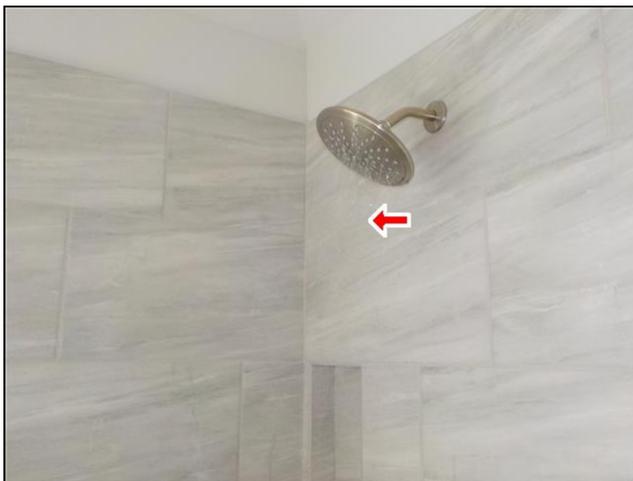
(2) Water flow was weak at the master shower.

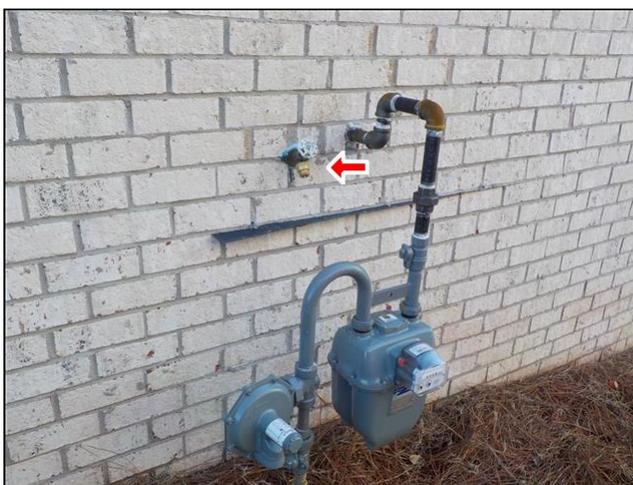
- 2 (3) There is poor placement of the exterior right side hose bibb being directly behind the gas meter. It should be moved to a more suitable location.

(3) There is poor placement of the exterior right side hose bibb being directly behind the gas meter. It should be moved to a more suitable location.

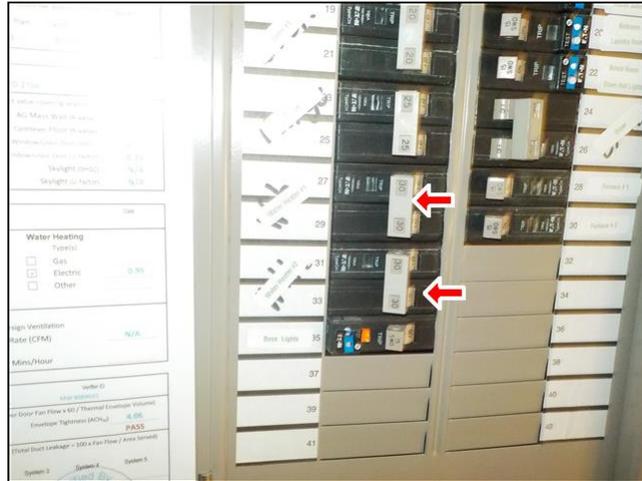
- 11 The water heater was not on and ready for the inspection, so a testing of the hot water could not be done.

The water heater was not on and ready for the inspection, so a testing of the hot water could not be done.

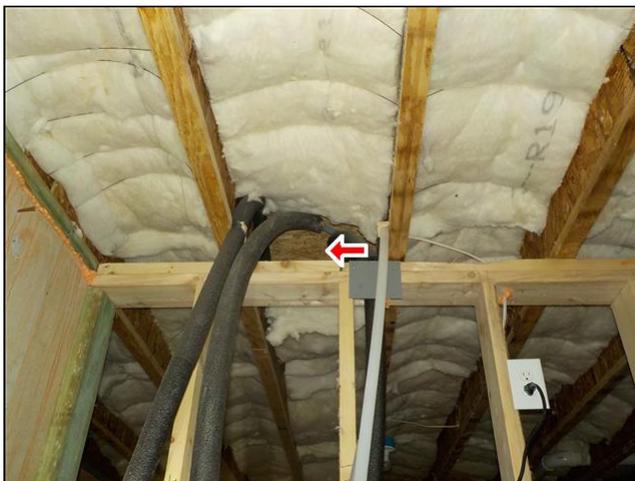
- 6 Incomplete insulation was observed on the ceiling above the water heater.

- 12 Incomplete insulation was observed on the ceiling above the water heater.

Incomplete insulation was observed on the ceiling above the water heater.

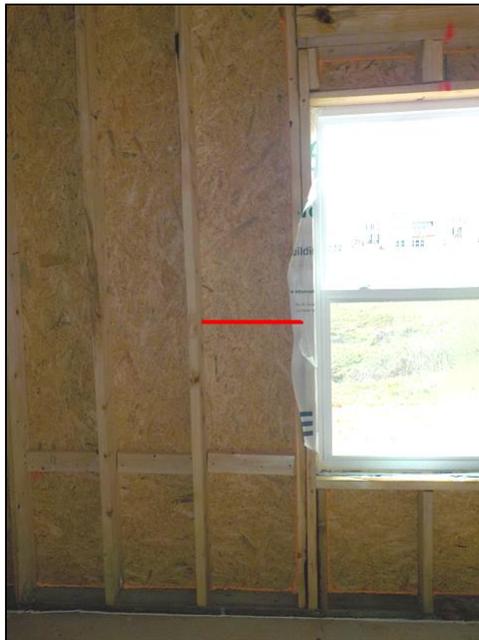
- 7 A set of studs is spaced over 16" on-center to the left of the far back windows in the unfinished basement.

A set of studs is spaced over 16" on-center to the left of the far back windows in the unfinished basement.

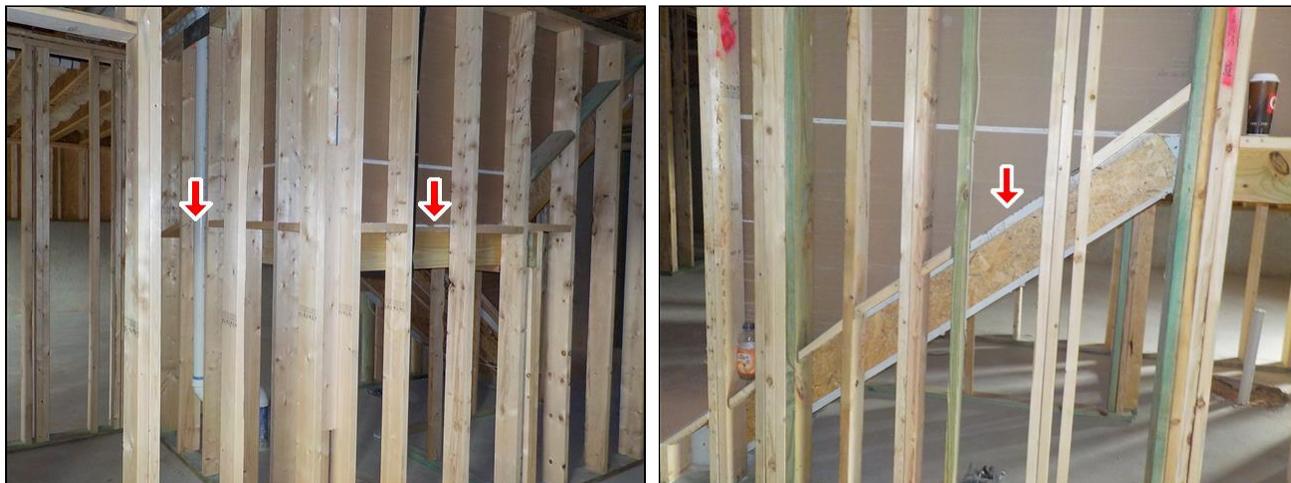
- 8 Missing and incomplete fireblocking was observed around the basement staircase.

Missing and incomplete fireblocking was observed around the basement staircase.

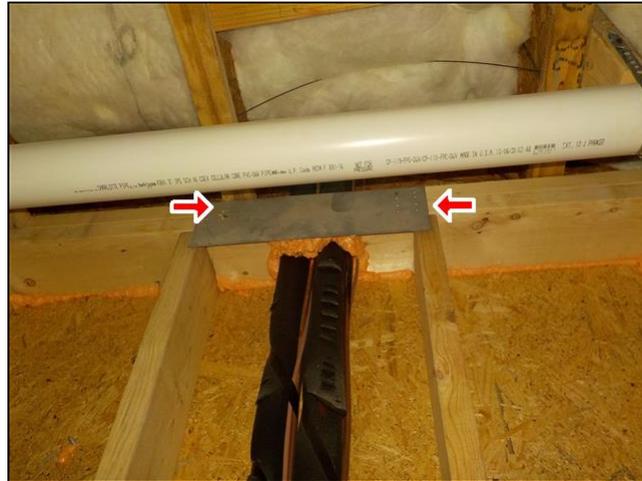
- 9 At the structural plate in the basement where the A/C lines goes through the wall, all of the required nails have not been added in the available nail holes. Otherwise, an engineer letter that approves the existing installation should be provided.

At the structural plate in the basement where the A/C lines goes through the wall, all of the required nails have not been added in the available nail holes. Otherwise, an engineer letter that approves the existing installation should be provided.

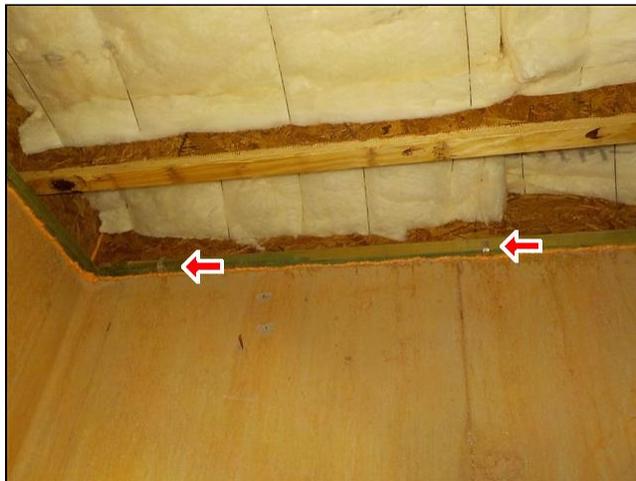
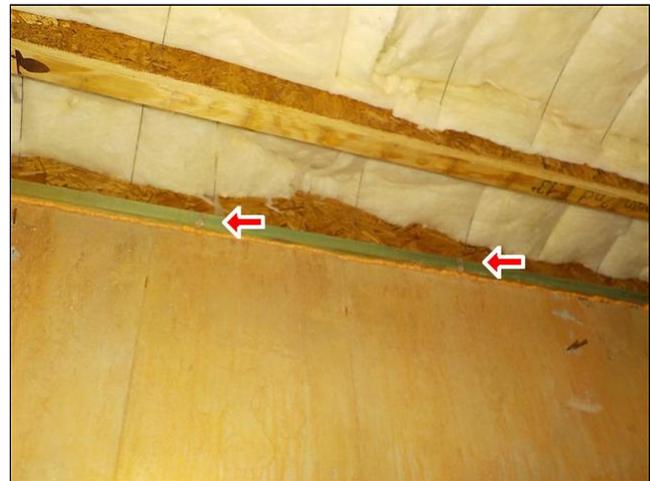
Issues were observed with the foundation anchoring in the basement, and it is recommended to have the anchoring further evaluated and repaired where needed:

- Unsecured foundation straps below the front porch.
- Straps that were not installed to the manufacturer specifications. In these cases typically Hilti nails are used as a substitute.
- Several straps that do not have all nail holes filled.

Unsecured

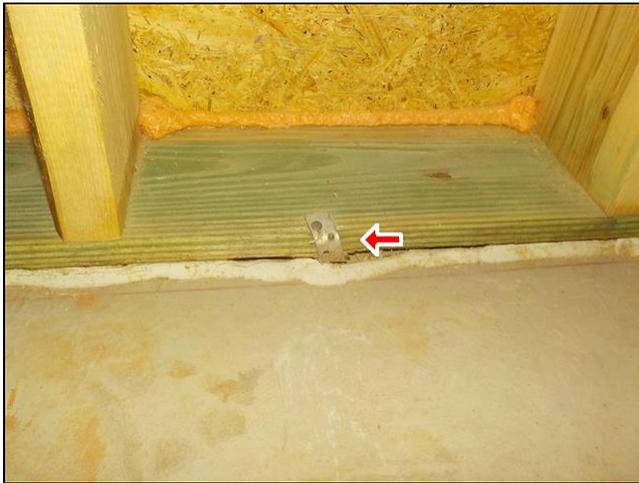
Example, not installed to manufacturer specs

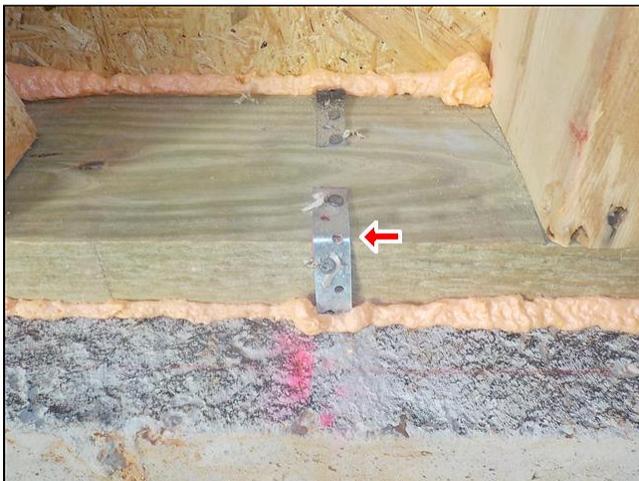
Example, missing nails

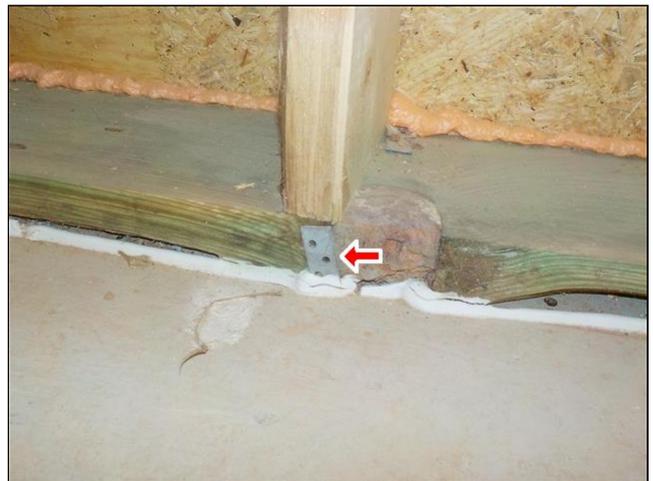
Unsecured and improper

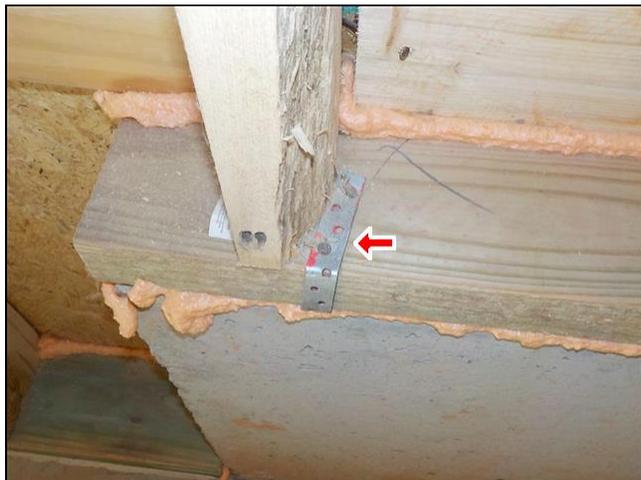
Missing nails

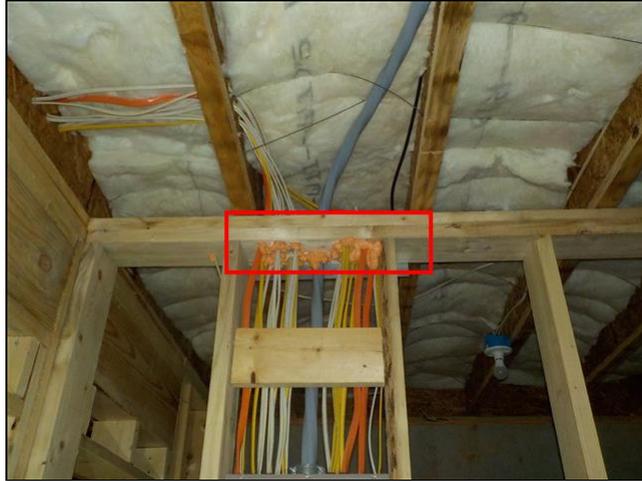
- 11 The top plate above the backside of the electrical panel needs a nail plate.

The top plate above the backside of the electrical panel needs a nail plate.

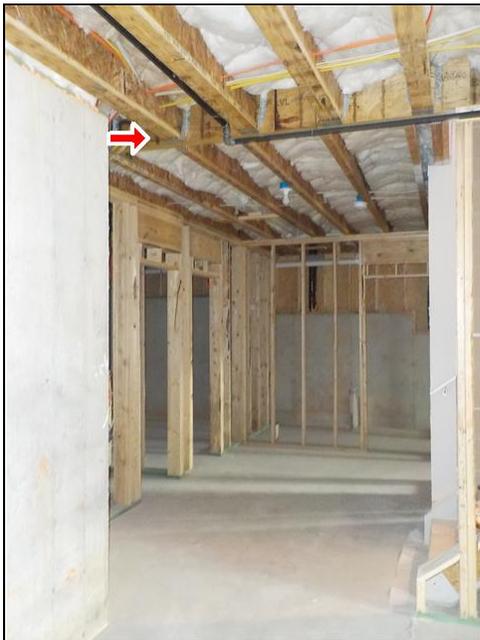
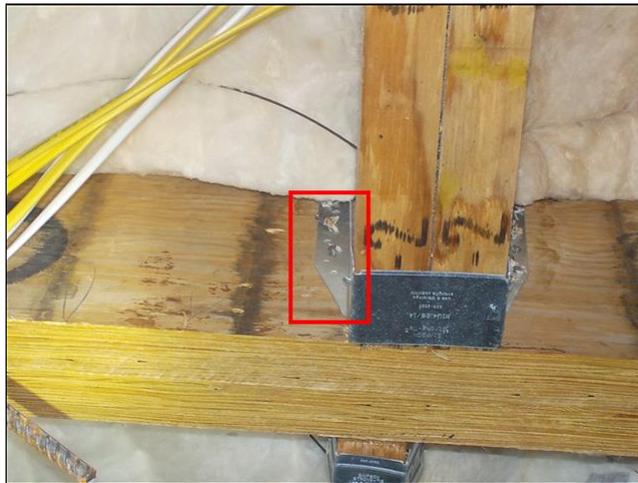
- 12 Inside the basement near the bottom of the stairs, there is a double I-joist hanger missing some nails.

Inside the basement near the bottom of the stairs, there is a double I-joist hanger missing some nails.

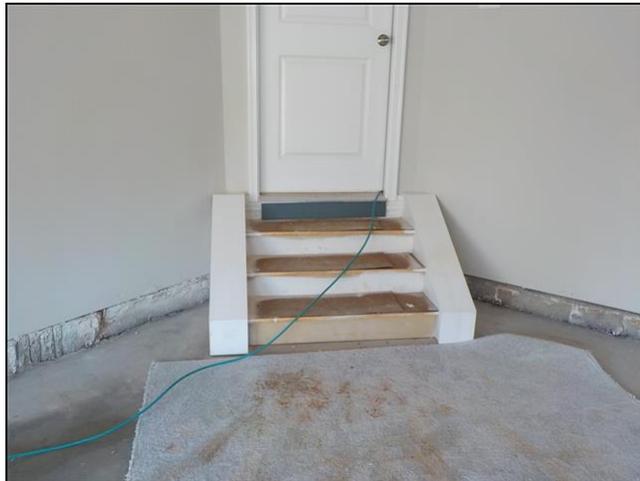
(1) A hand railing is missing at the garage stairs.

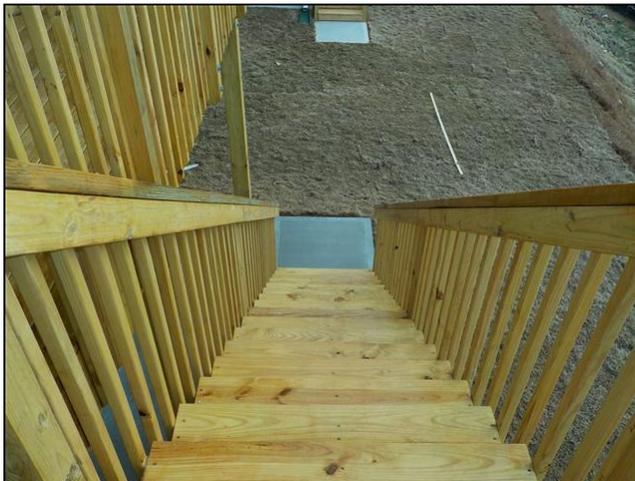
(2) A hand railing is missing at the deck steps.

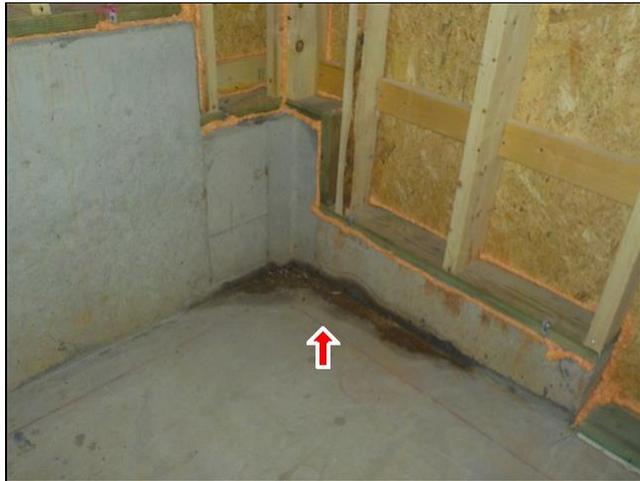
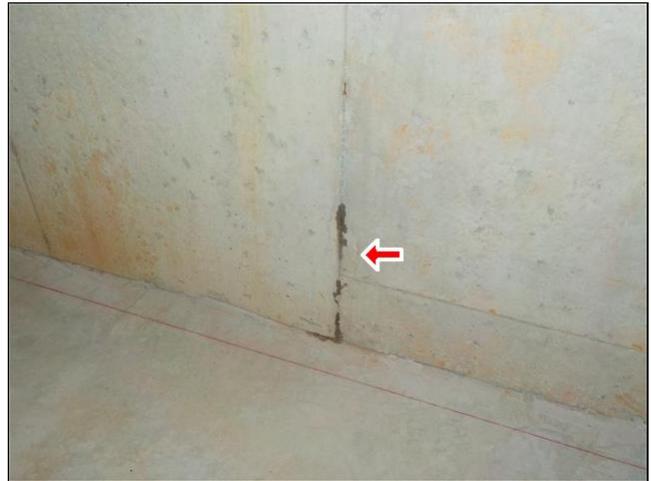
**12.0 FOUNDATIONS, BASEMENTS, CRAWL SPACES**

- 13 Water penetration was observed in the basement at the back left corner of the house and along the exterior right side wall. My initial thought was this was related to the pressure washing being done at the time of the inspection. However, the buyer indicated these have been present for several weeks if not longer. This should be evaluated by the builder and corrected as needed.

Water penetration was observed in the basement at the back left corner of the house and along the exterior right side wall. My initial thought was this was related to the pressure washing being done at the time of the inspection. However, the buyer indicated these have been present for several weeks if not longer. This should be evaluated by the builder and corrected as needed.

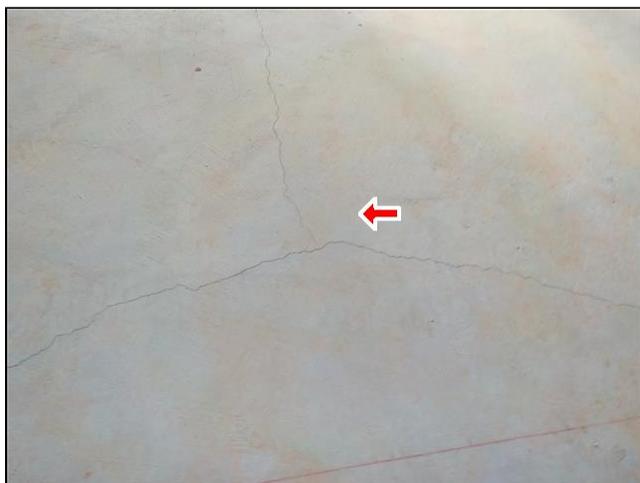
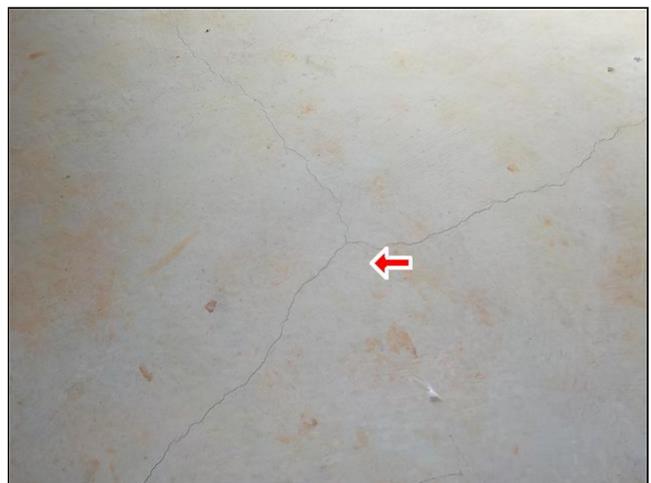
(1) Common curing or settling cracks were observed on the foundation floor. Contact the builder to understand their policy for cracked concrete.

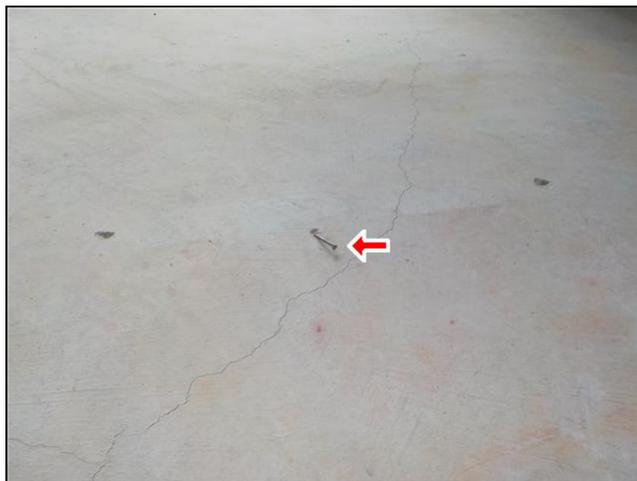
(2) A nail is sticking up from the concrete floor in the basement near toward the far back windows.

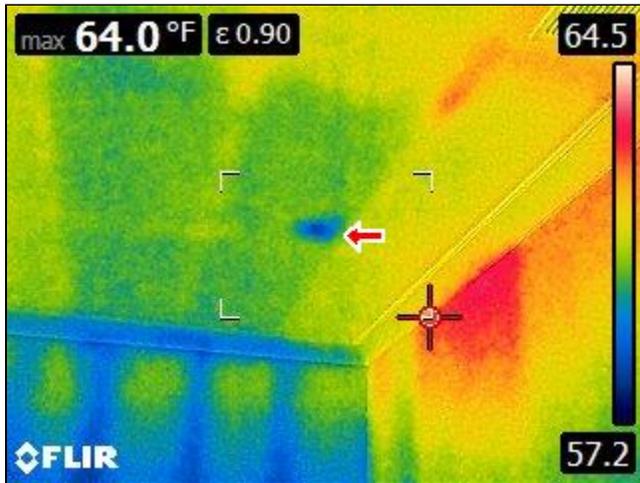
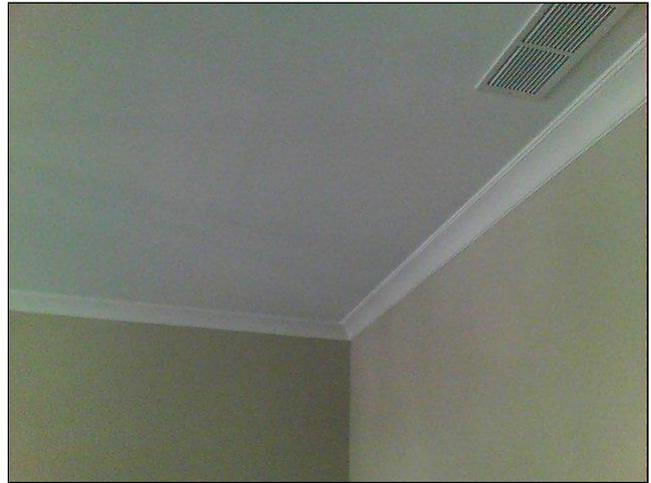
What appears to be water was detected on the dining room ceiling using an infrared camera. The cold/blue area in the thermal image is consistent with water. There is no plumbing directly above here but it is near a bathroom. Have evaluated and repaired as needed.

Thermal image of suspect leak

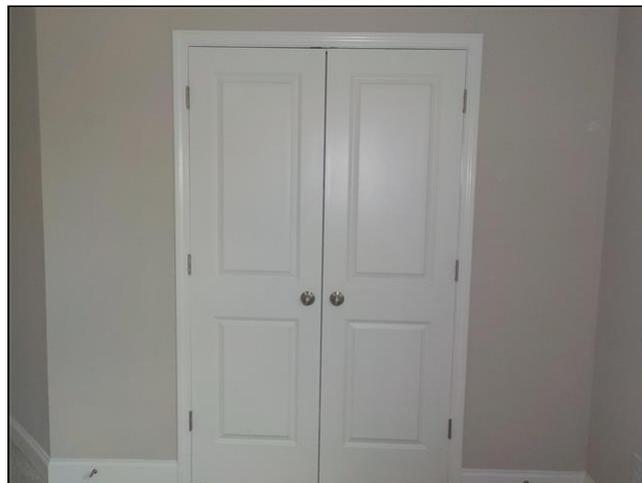
(1) The large bedroom over the garage has closet doors that need adjusting. One has a stuck ball catch, and the other rubs against the carpeting.

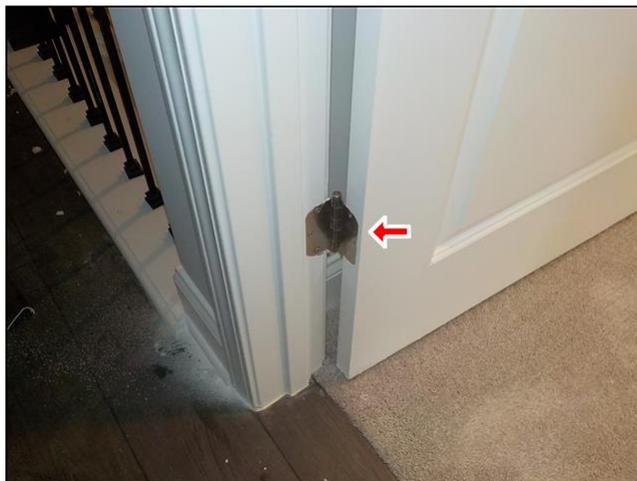
(2) The bottom hinge is loose at the master bedroom entrance door.
