# Pre Drywall Inspection Report

Dartmoor @ Mountain Crest Lot 414  
Cumming GA 30040

1/12/2021

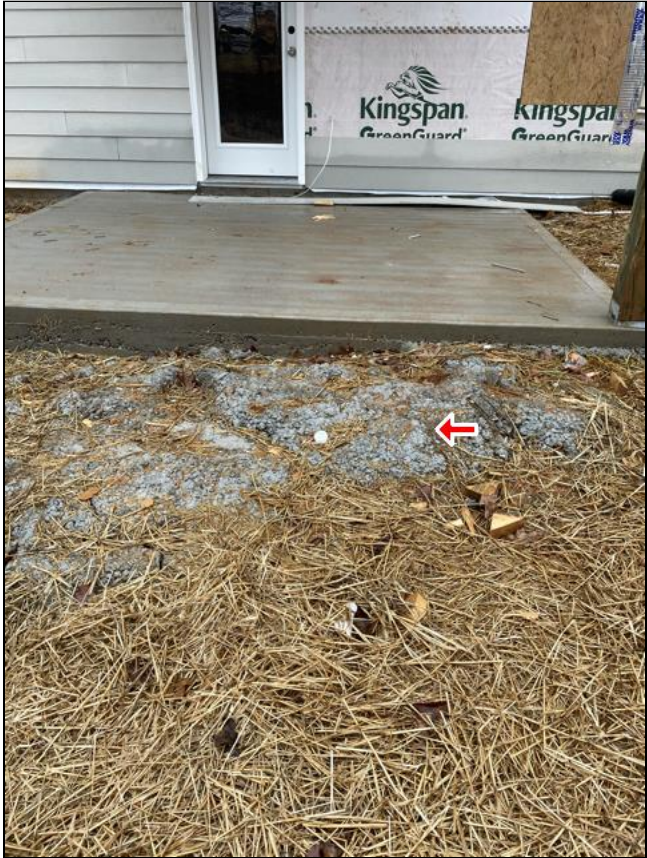
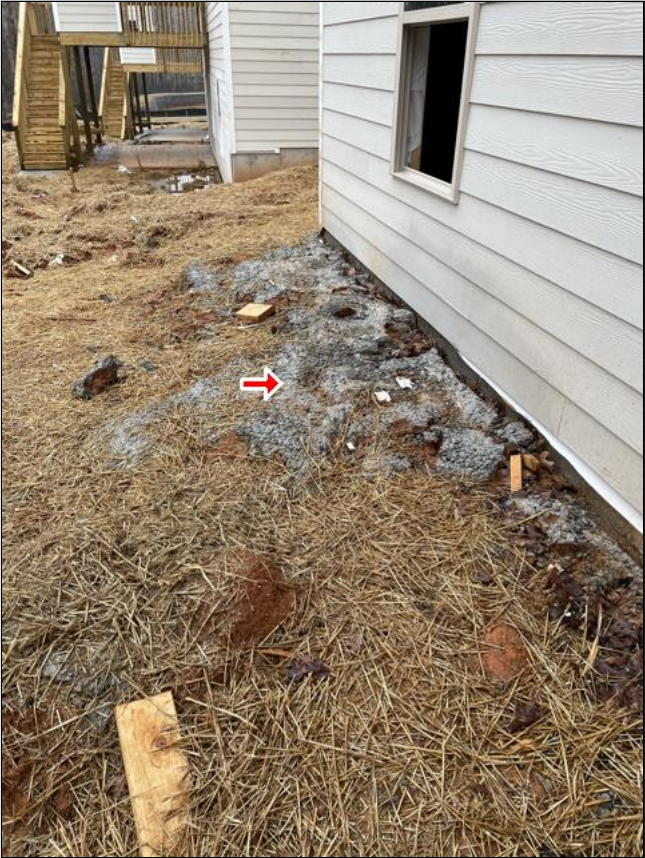
**1.8 EXTERIOR GENERAL**

Excessive amounts of concrete were observed in back on the ground and should be removed as needed.

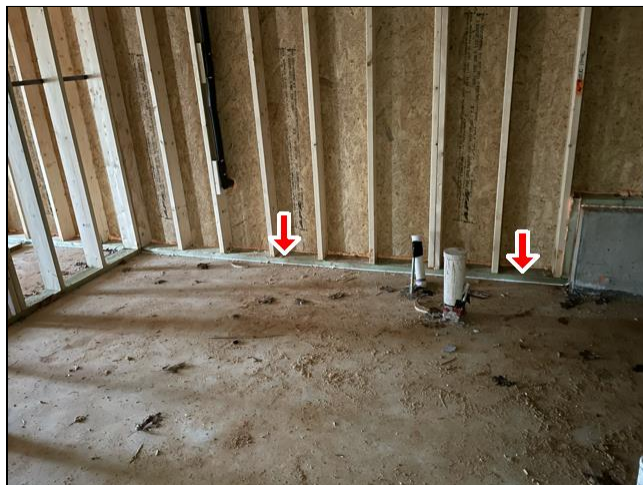
There's typically a third party engineering evaluation that includes evaluating the foundation anchors. I saw several issues in the unfinished basement with the foundation anchors including unsecured sill plate straps, missing foundation anchors, and foundation anchors that were not installed to the manufacturer specifications. Confirm with the builder that the third-party evaluation will be done. Otherwise have the foundation anchors evaluated and repaired where needed.

Missing anchors bathroom area

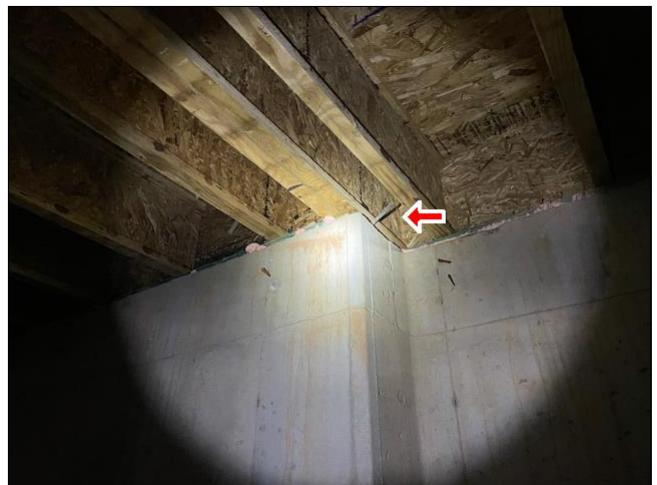
Loose strap front wall below front porch

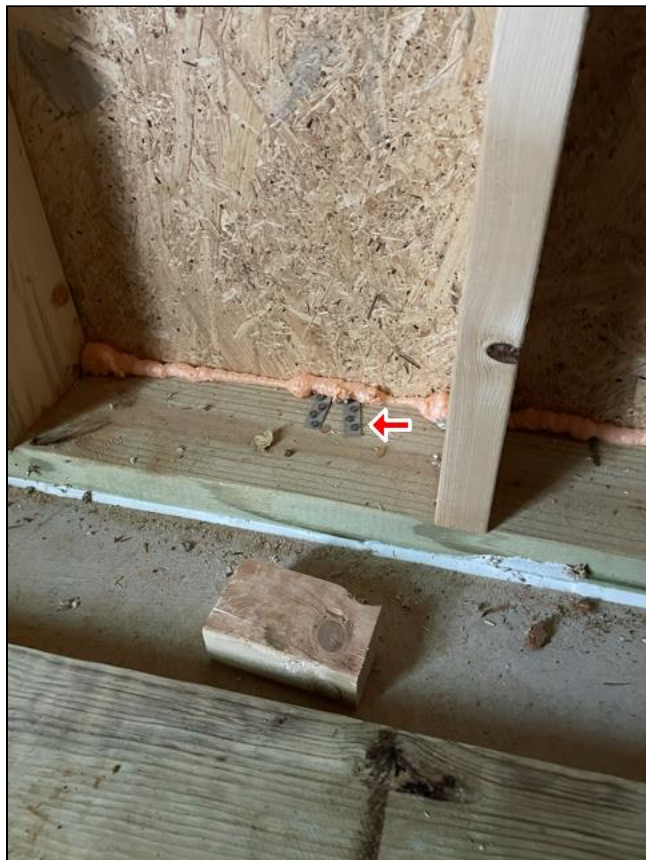
Straps not installed to manufacturer's installation guidelines.

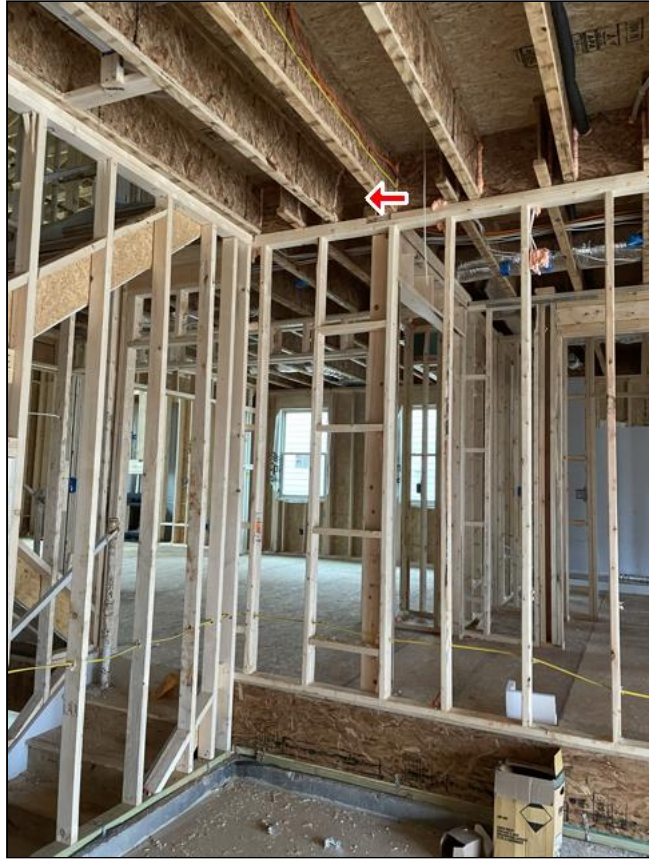
(1) Fire blocking is incomplete at the back right corner of the garage.

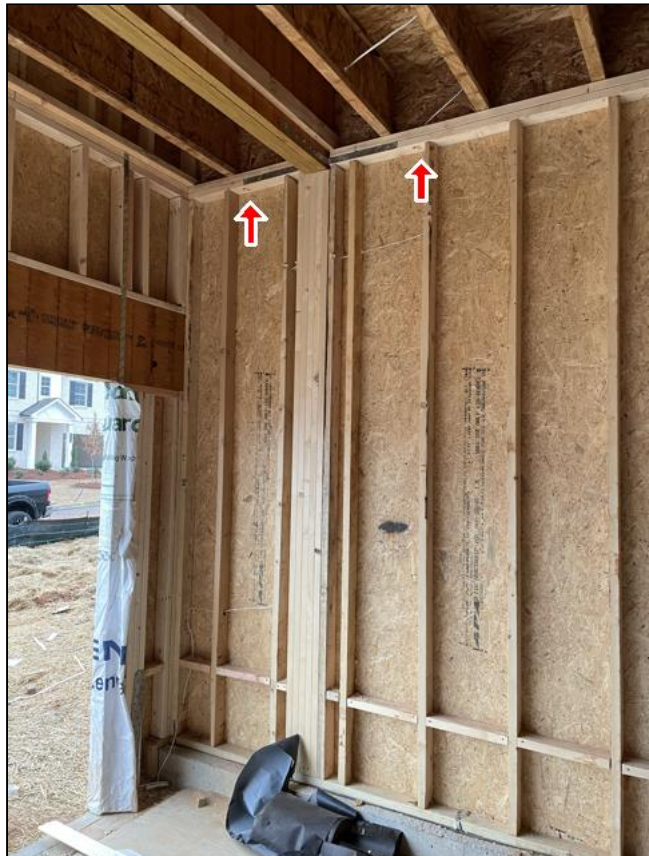
(2) Two openings in top plates were observed in the garage on the exterior wall near the front.

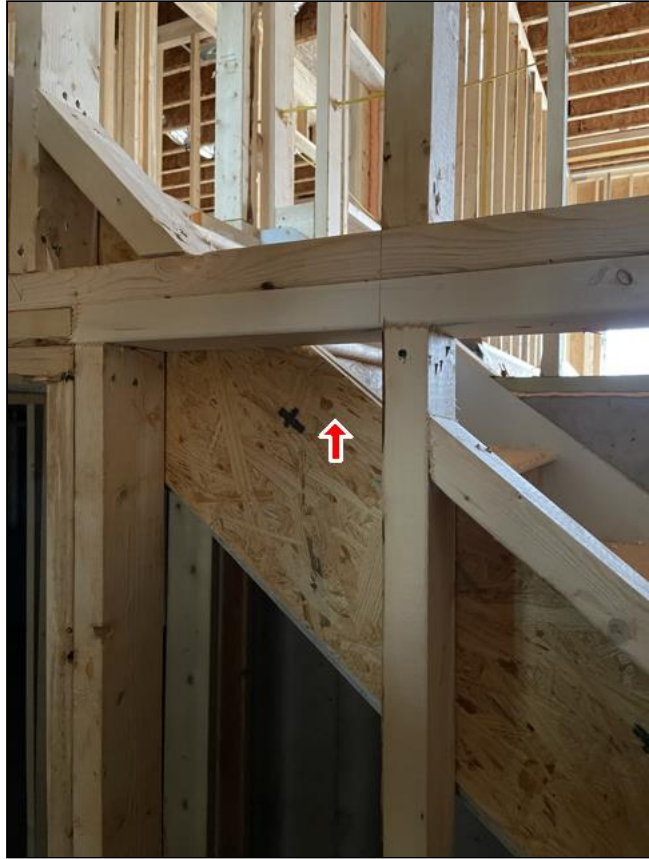
(3) A piece of wood fire blocking is missing at the basement stairs on the lower flight of the staircase.

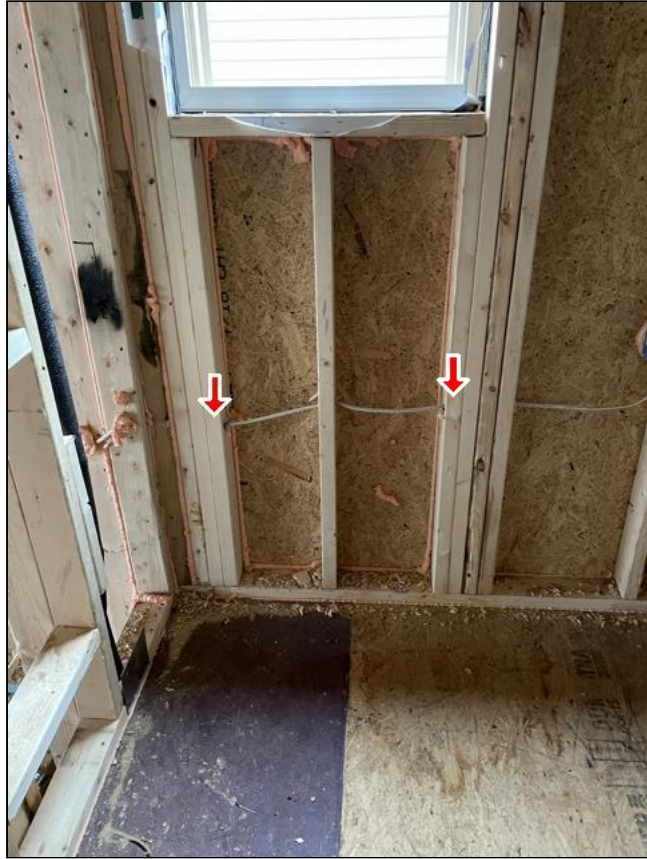
(1) Two nail plates are needed in the mudroom where a wire was run too close to the surface of the studs.

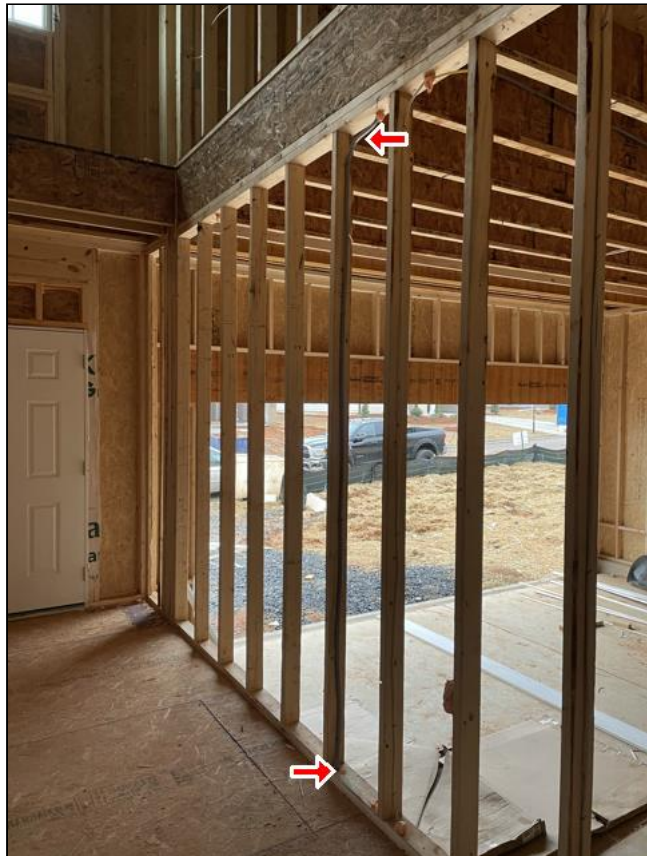
(2) In the foyer hallway there is a gray electrical wire that needs nail plates at the sill plate and the top plate where it runs too close to the surface of the wood.

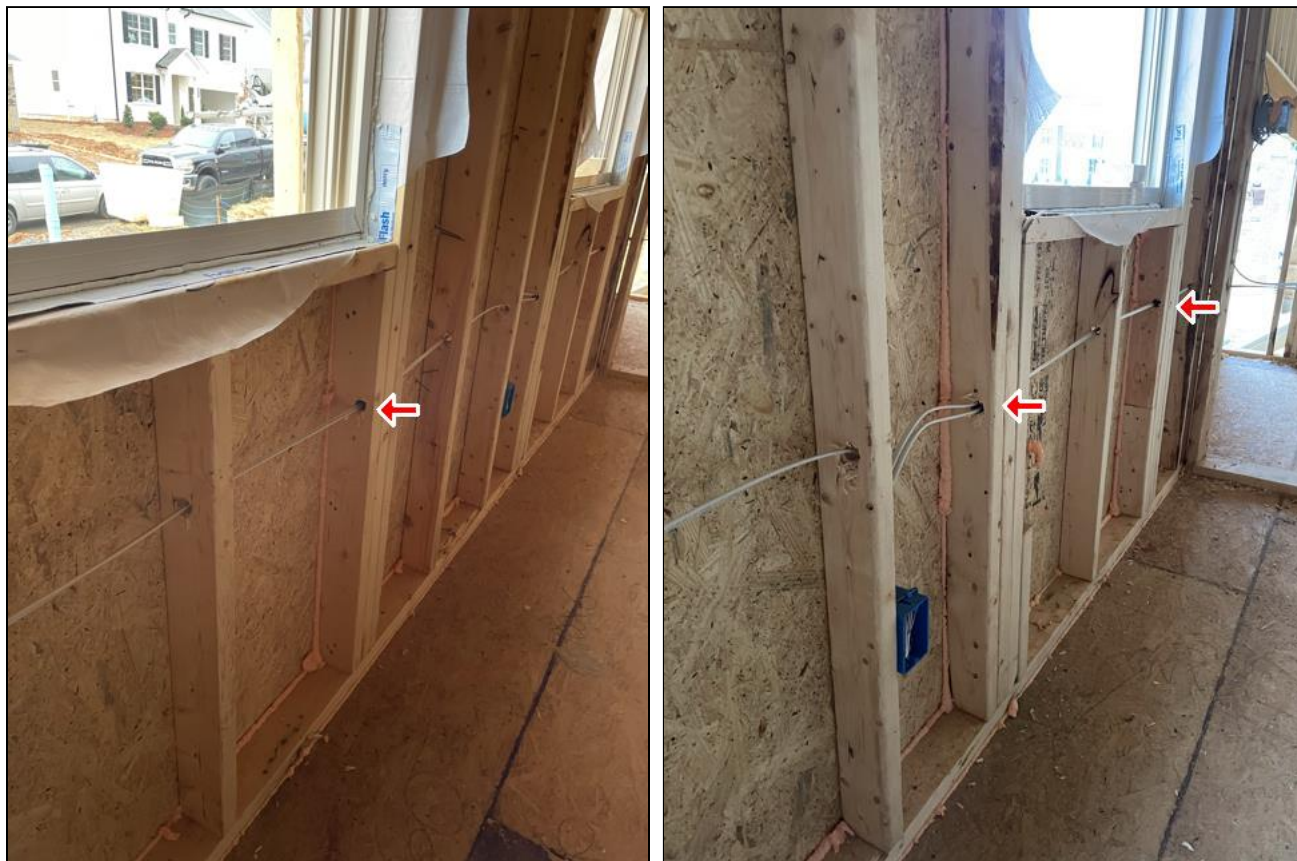
(3) At the front wall of the first floor office room, nail plates are needed where a wire was run too close to the surface of the studs.

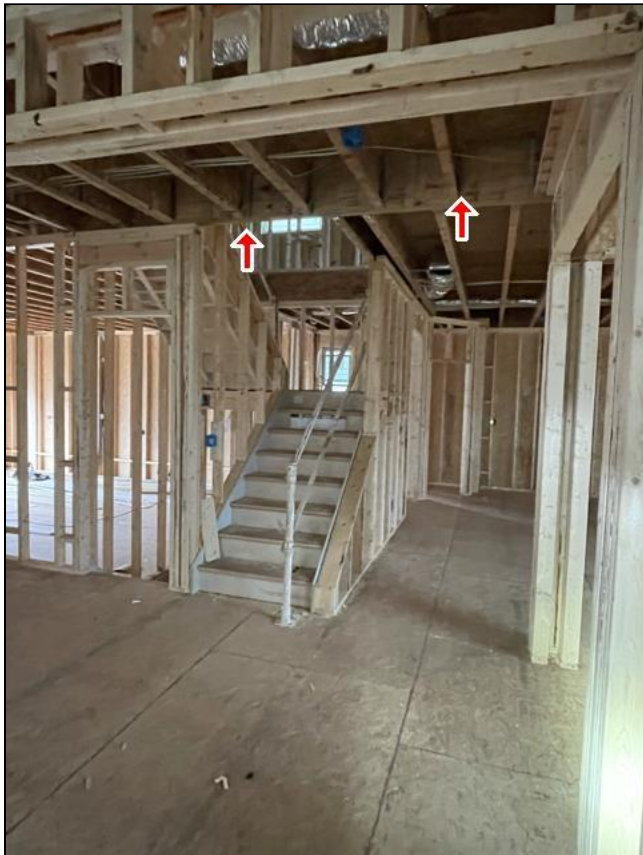
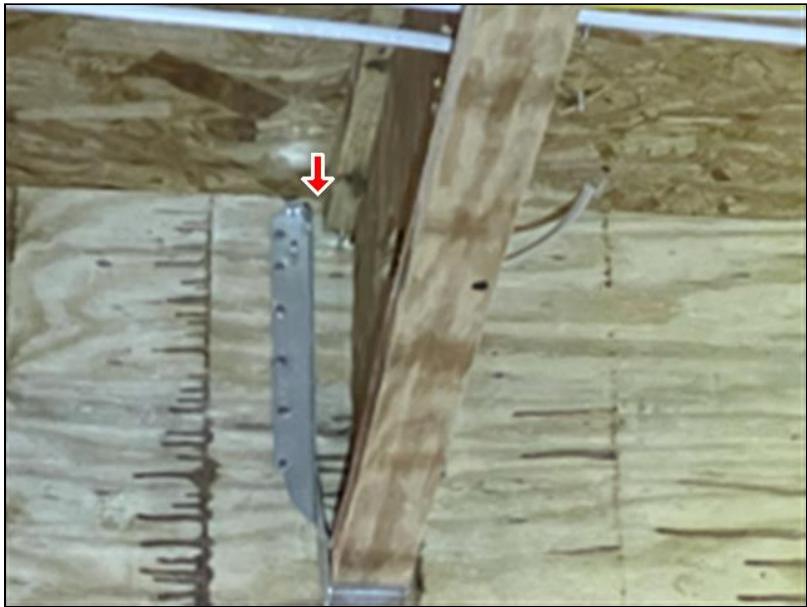
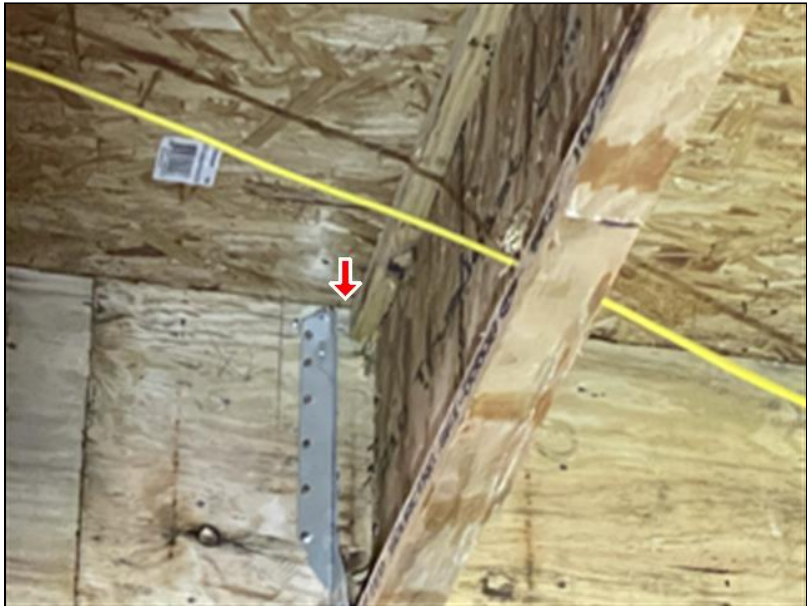
**2.27 FLOOR JOIST AND FLOOR TRUSS HANGERS**

In the ceiling at the bottom of the second floor staircase, there are two I joist hangers that are not in contact with the top flange of the I joists.

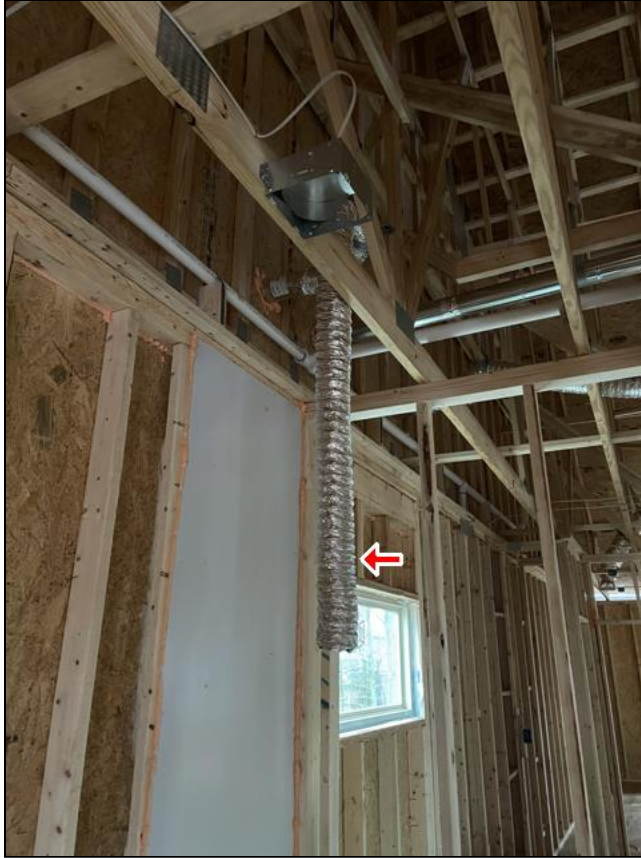
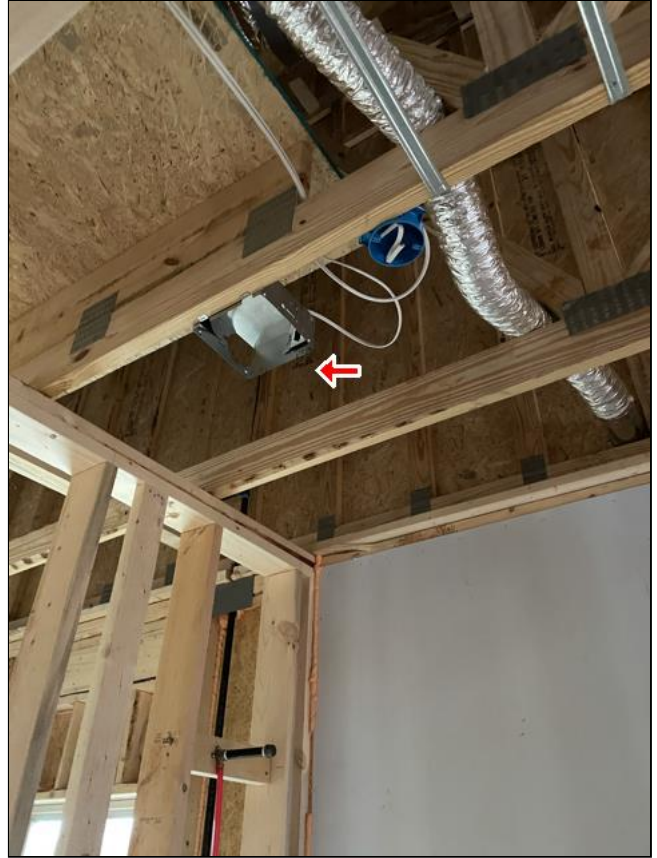
3.0 EXHAUST SYSTEMS (BATH VENTS/CLOTHES DRYER) (IMC M501)

Both second-floor guest bathroom vent fan ducks have not been attached.

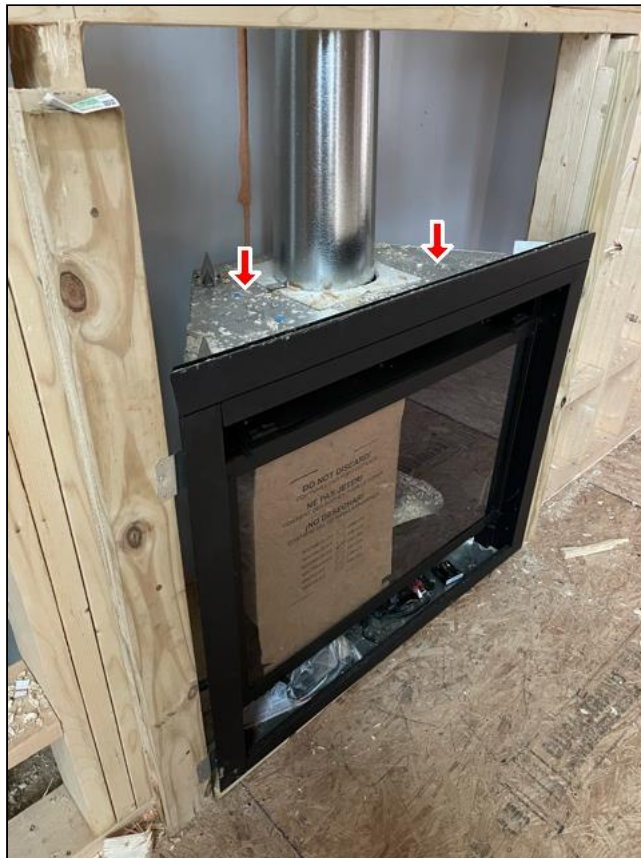
### 3.2 FIREPLACES & CLEARANCES TO COMBUSTIBLES

All combustible wood debris on and around the fireplace should be removed.

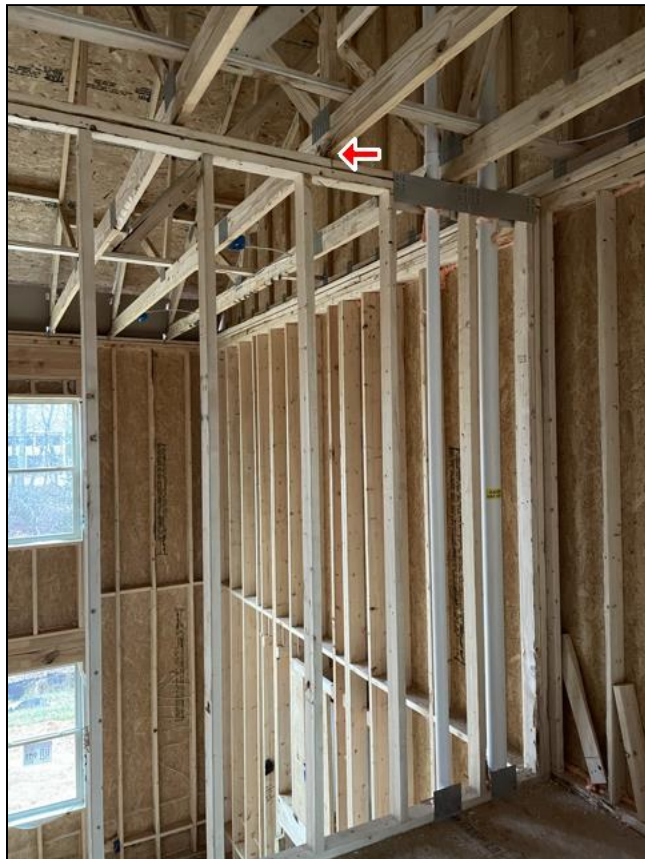
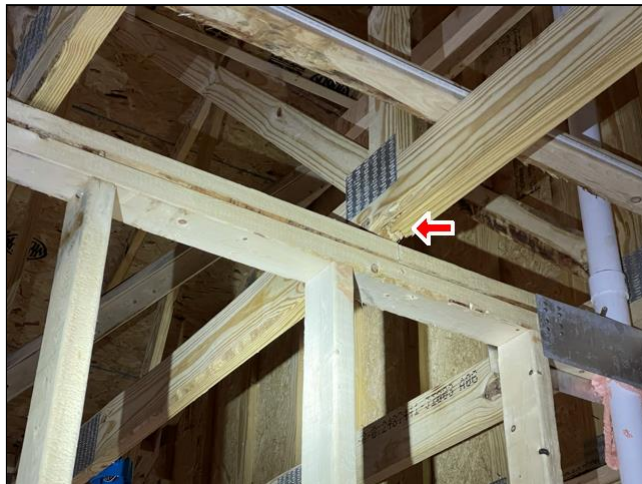
6.7 TRUSSES OR RAFTER INSTALLATION

A damaged bottom cord of a roof truss was observed in the back Jack and Jill bedroom. Have reviewed by the registered design professional and repaired as needed. Documentation should be left for future reference.

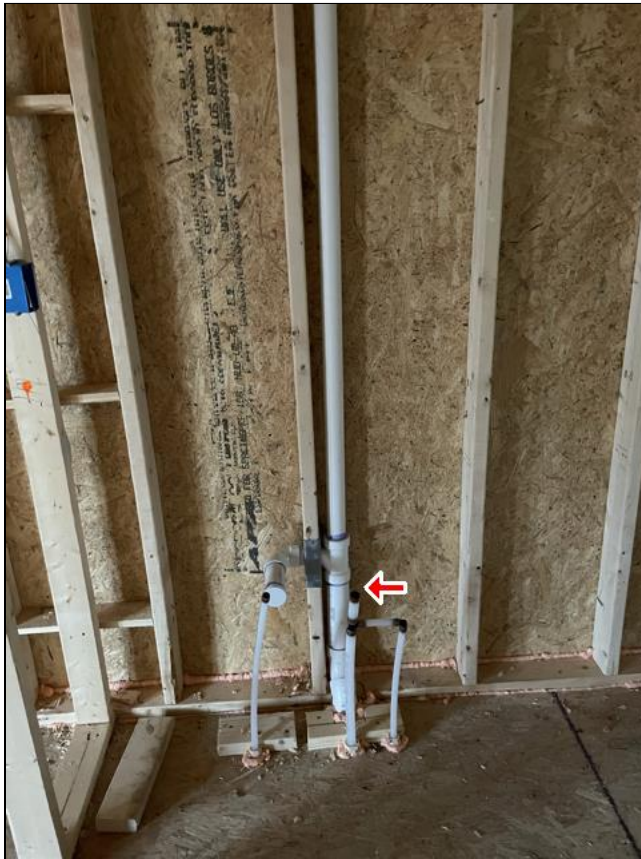
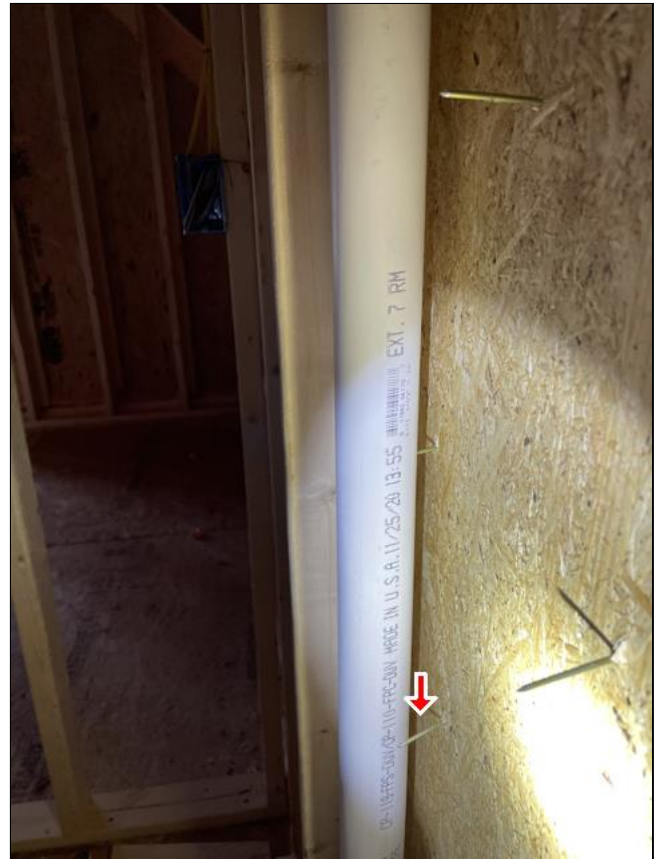
(1) In the second-floor guest bathroom over the garage, the PVC vent stack has been penetrated by a nail coming in from the outside.

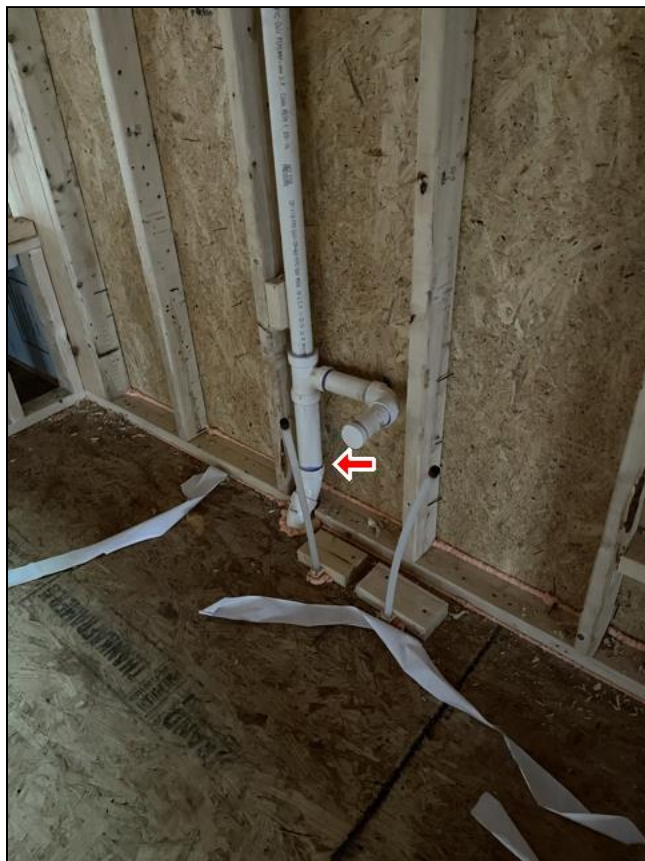
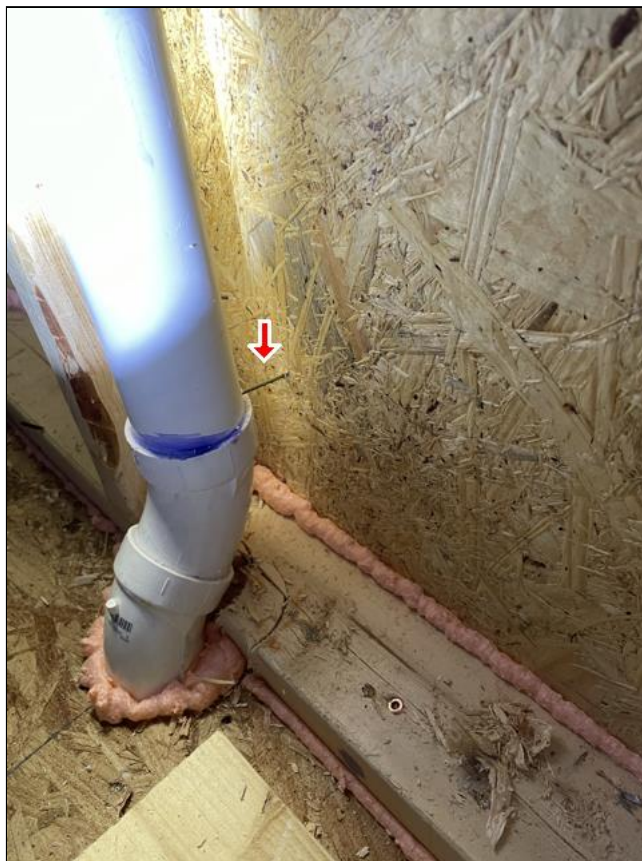
(2) The master sink located on the outside wall has a PVC drain that has been penetrated by a nail coming in from the exterior.

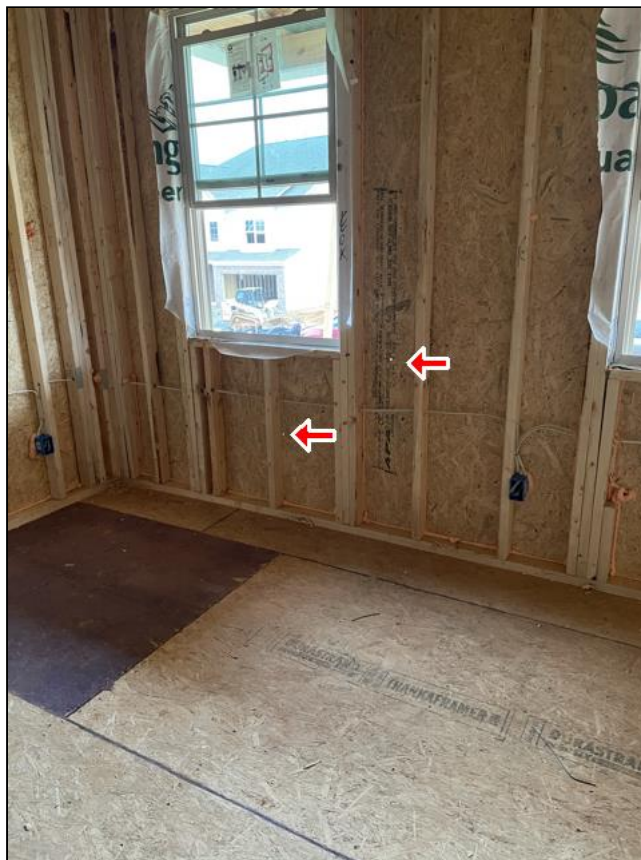
Two areas of visible daylight through the OSB wallboard in the front office room should be foam sealed.

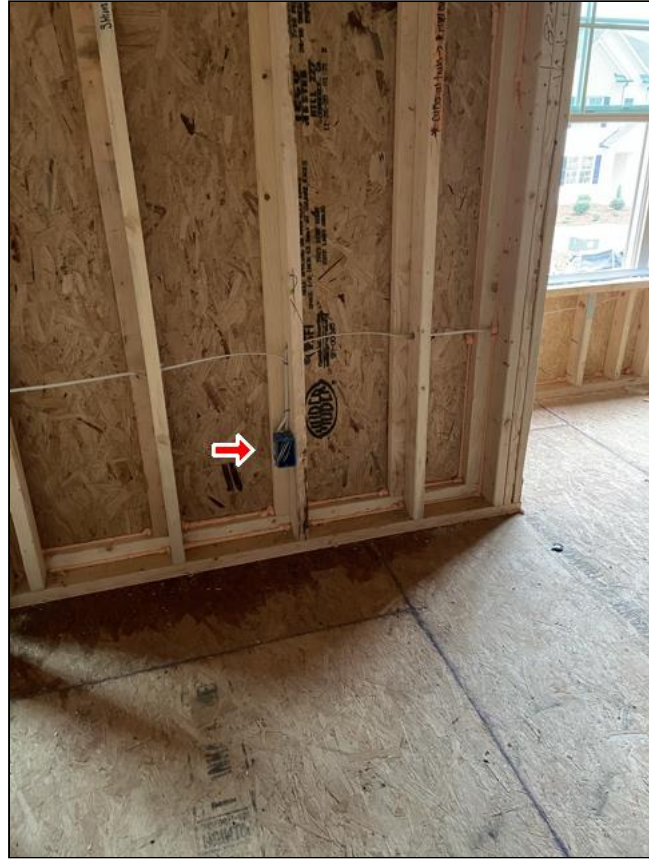
### 12.14 AIR SEAL BEHIND ELECTRICAL BOXES (TABLE 402.4.2)

In the second-floor bedroom over the garage, one of the front electrical outlets is lacking foam insulation behind it.
