# Inspection Report

**Property Address:**  
4474 Karls Gate Dr  
Marietta GA 30068

**Dana Inspection Services, Inc.**

<b>Date:</b> 12/21/2020		
<b>Property:</b> 4474 Karls Gate Dr Marietta GA 30068	<b>Customer:</b> Jonathan Bussell	<b>Real Estate Professional:</b> Lisa Collins Atlanta Fine Homes Sotheby's International Realty - Atlanta

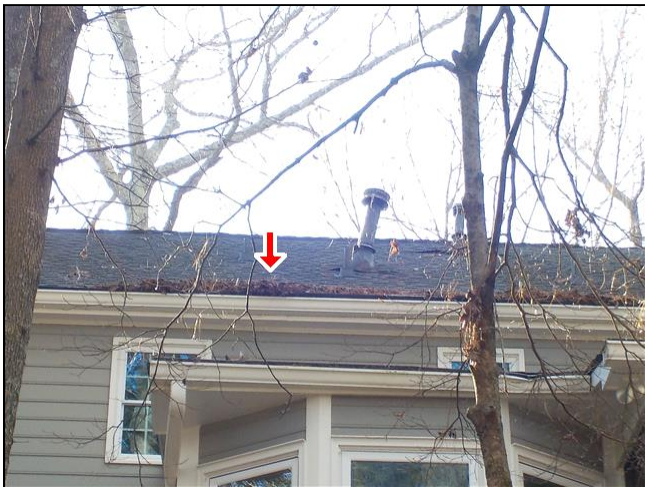
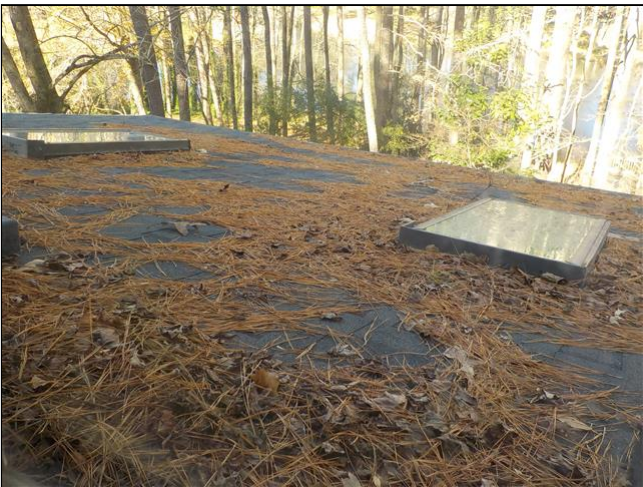
A lot of leaf debris was observed on the back of the roofs.

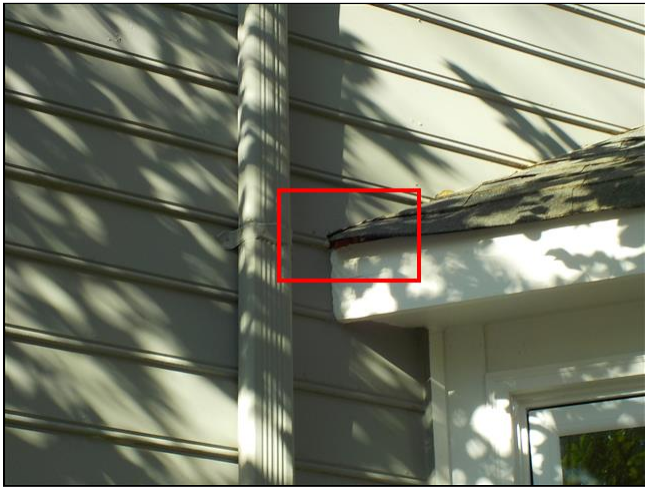
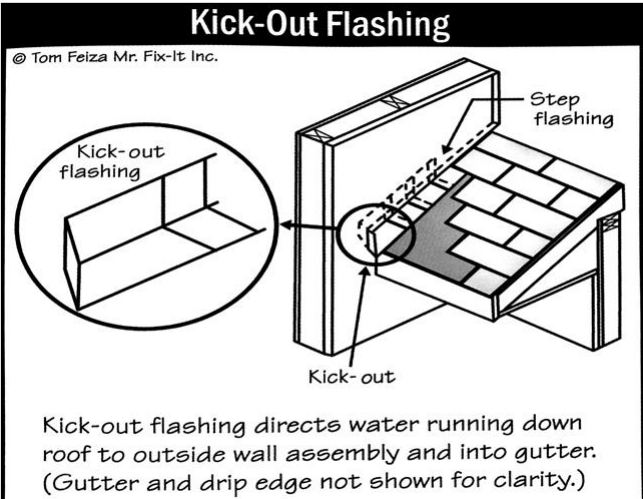
1.2 FLASHINGS

Kickout flashing is missing at the roof/sidewall transitions on the dining room bay window roof.. Have all areas further evaluated and repaired where needed by a qualified roofer.

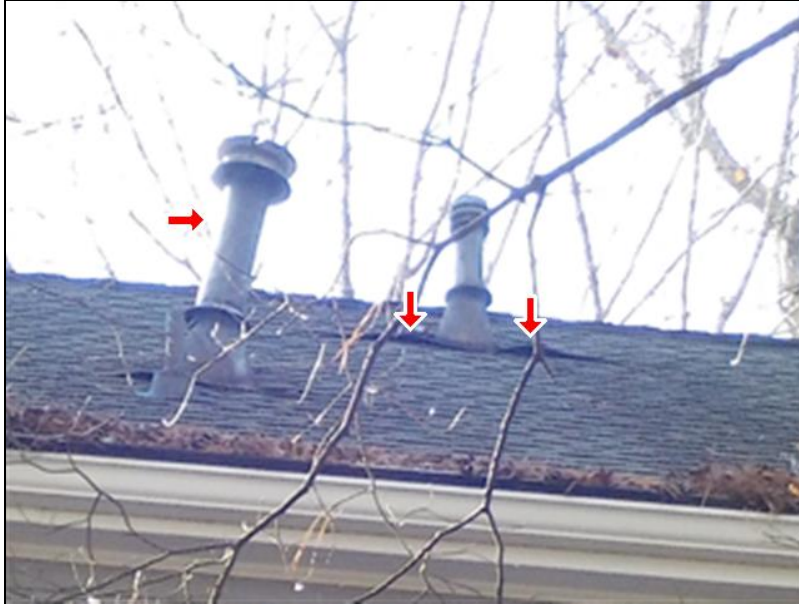
There are issue with two metal exhaust vents above the back roof that should be further evaluated and repaired by a qualified roofer as they appear to be causing leaking. One of the vents is very crooked, and the other has the metal boot coming loose and causing shingles to not sit flat. There are stains and evidence of previous wetness on the ceilings in the 2nd floor guest bathroom and hallway linen closet, and on the insulation in the attic.

View of the two vents

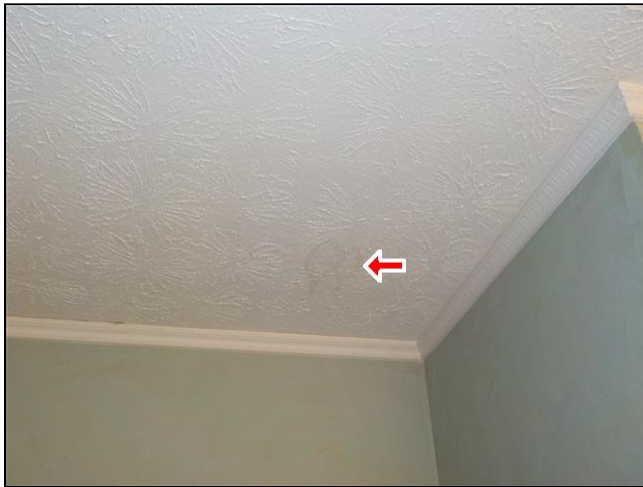
Ceiling stain 2nd floor guest bathroom

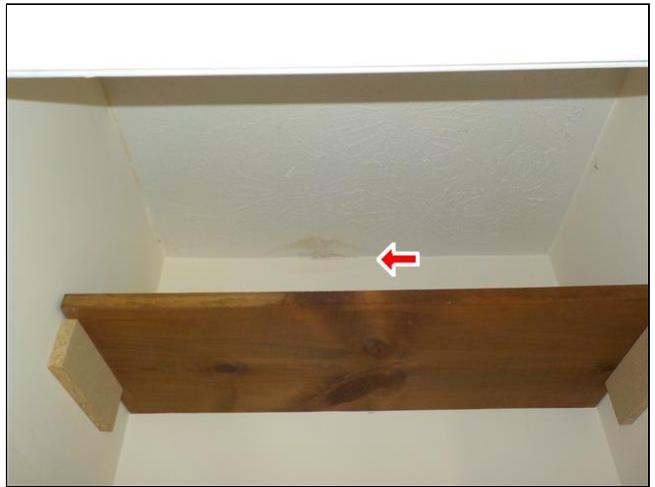
Ceiling stain hallway linen closet

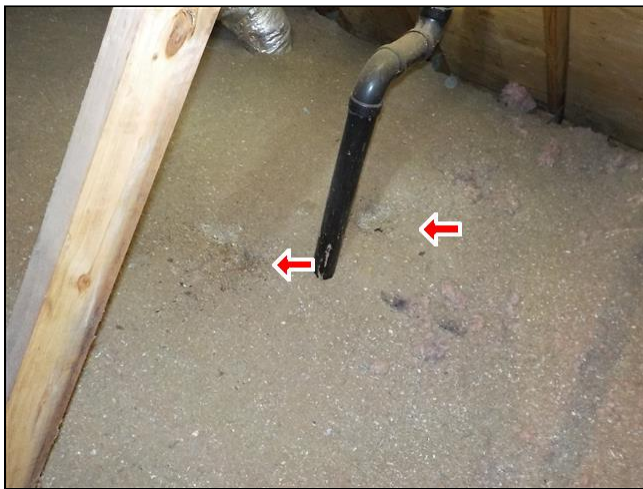
Evidence of previous wetness on insulation

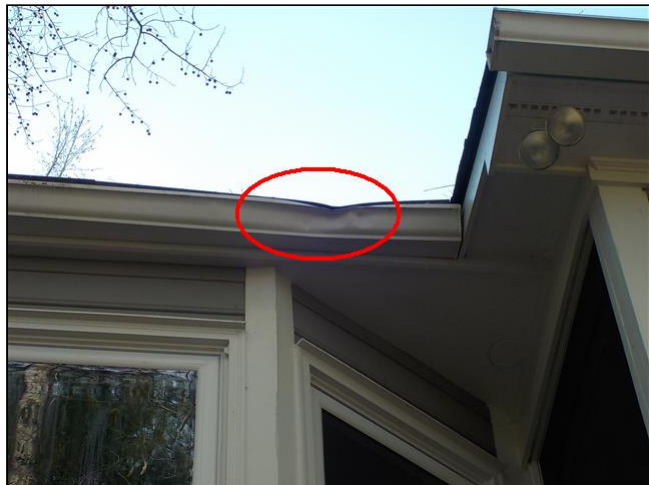
A dented gutter was observed in back.

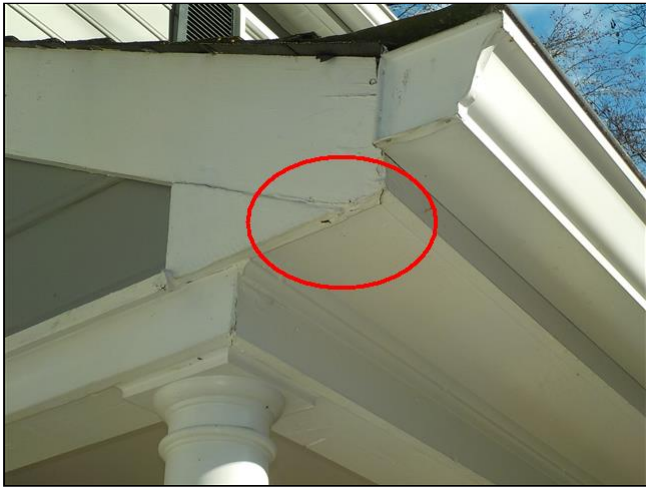
(1) A small area of wood rot was observed on the trim at the left end of the front porch soffit.

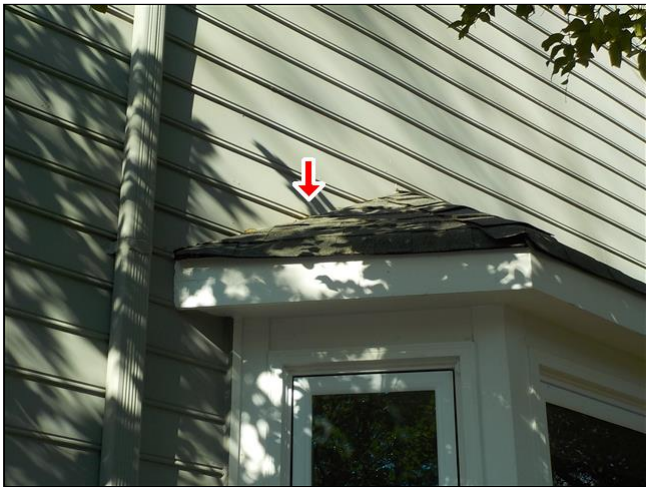
(2) Lapboard siding is in contact with the roof shingles above the dining room bay windows . This is a common problem when the original, flatter shingles are replaced with thicker, architectural ones. To prevent accelerated deterioration, it is recommended to cut the siding up off the shingles.

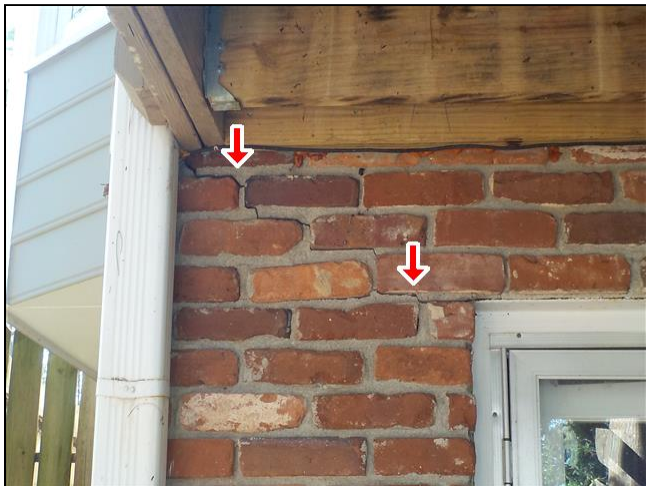
Backside

(3) Cracks in the brick veneer were found in several locations around the house. It is recommended to have the cracks further evaluated by a qualified contractor and sealed or repaired as needed.

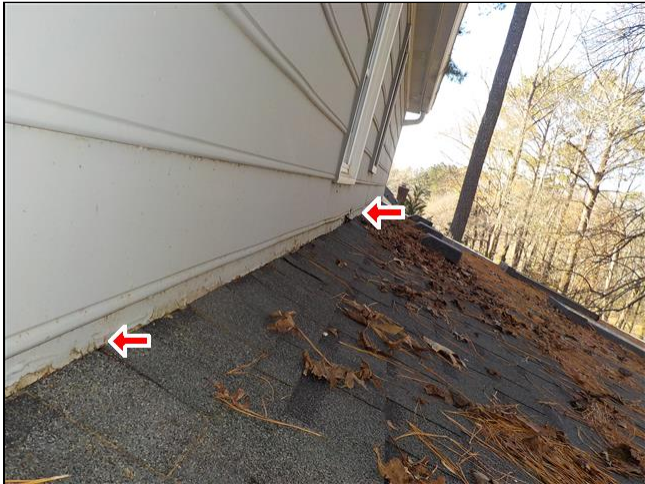
View 1

(4) Deteriorated siding was observed at the back of the house directly above the covered back porch roof.

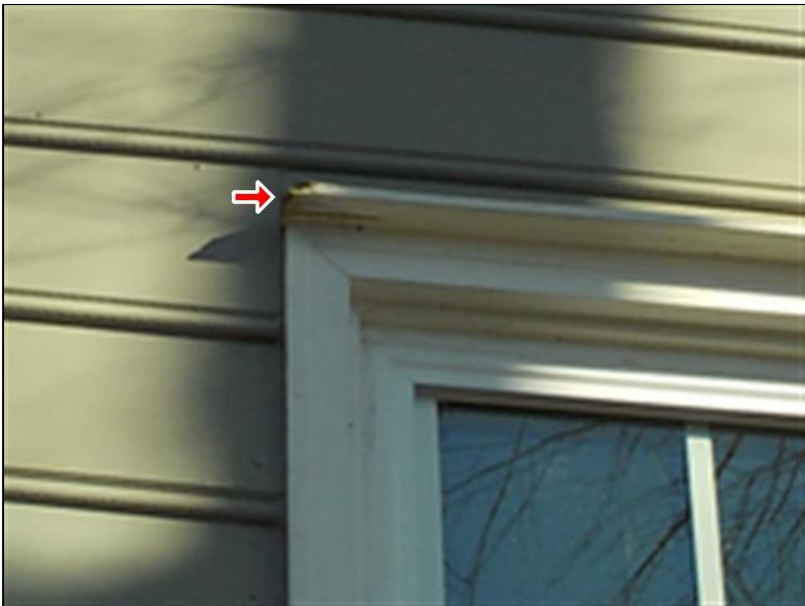
(5) A small amount of wood rot was observed on the trim above the garage window.

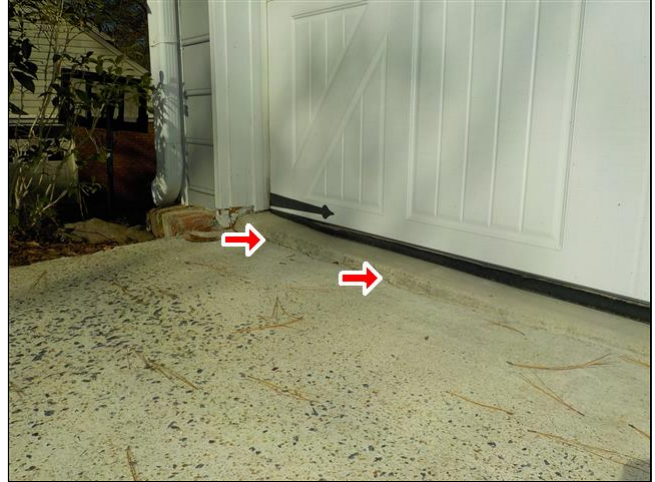
(1) Many cracks were found on the driveway, as well as some settling causing displacement. This is most pronounced in front of the left hand garage opening where a moderate lip is present. Have the driveway further evaluated and repaired as needed by a qualified driveway professional.

Lip at garage entrance

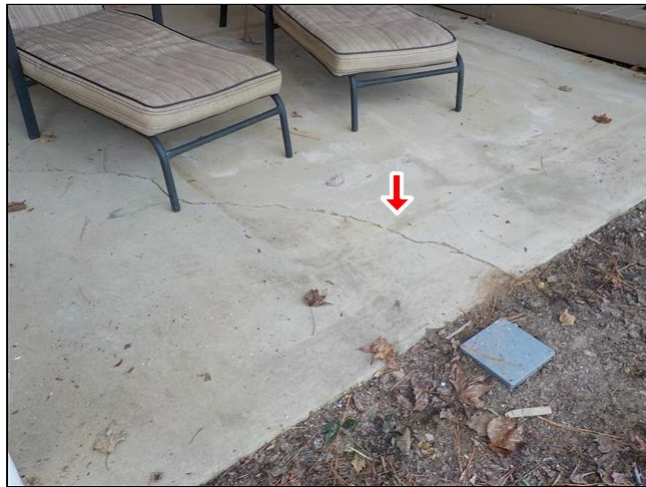
(2) Common settling cracks were observed on the back concrete patio.

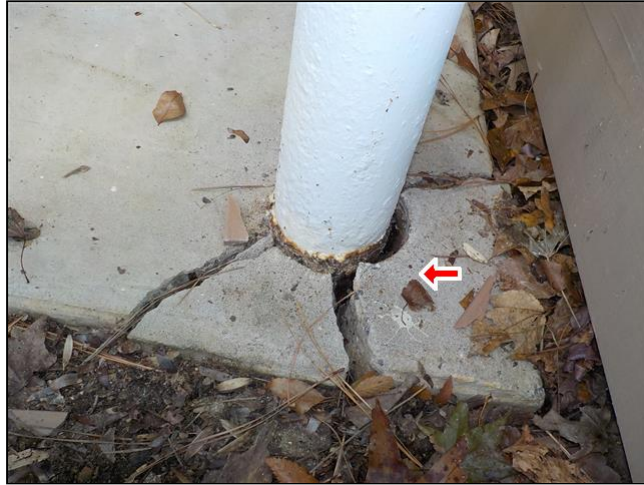
(3) Cracked concrete around one of the metal support posts was observed in back.

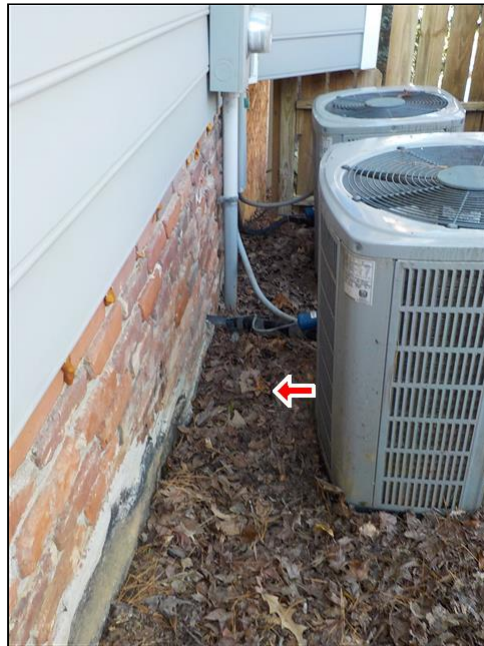
(4) There is a negative grade at the A/C units on the exterior right that may place excessive amounts of moisture up against the foundation.

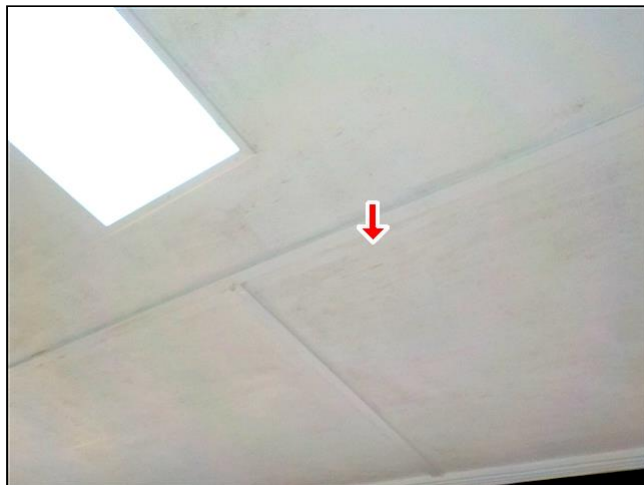
A stain was observed on the covered back porch ceiling that I suspect is actually a part of the painted wood as opposed to a roof leak. No issues with the shingles were found.

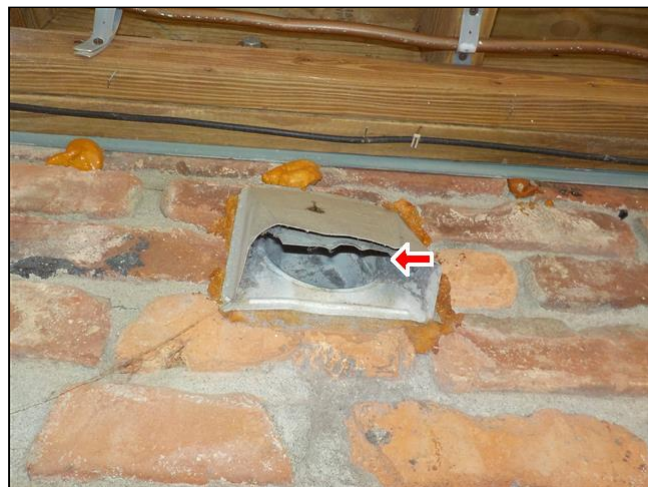
the dryer vent hood in back has a damper that is not shutting.

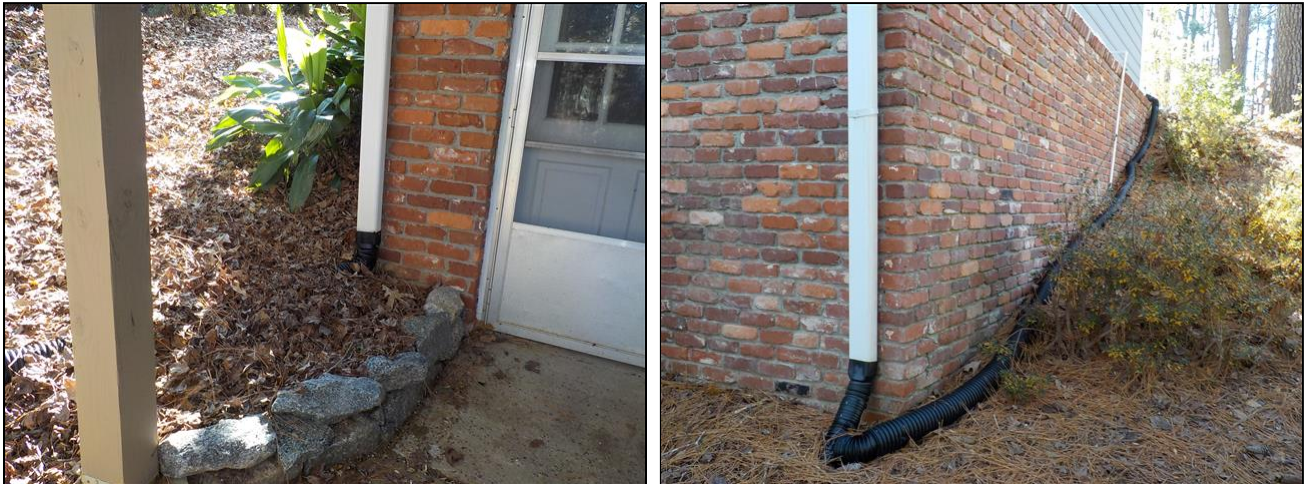
I was unable to locate where the foundation drains terminate at the back two corners of the house. This is common for a house of this age.

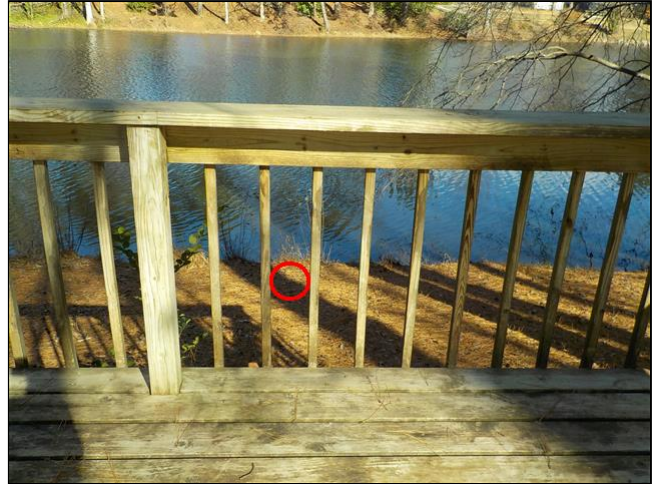
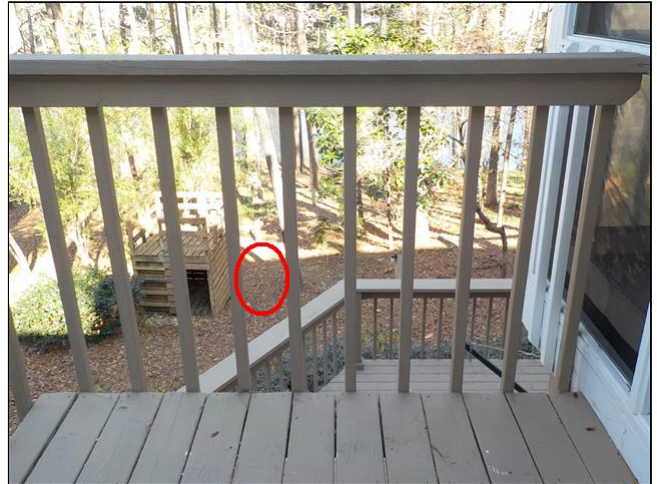
(1) At all of the decks, the balusters are spaced over 4" apart, which is considered a safety hazard by today's standards.

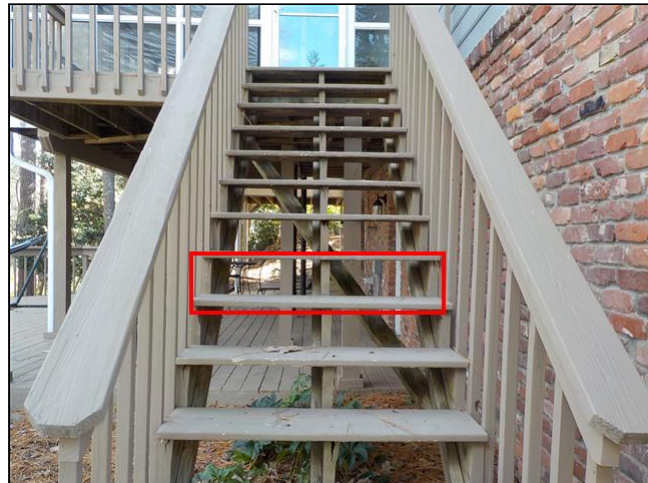
(2) Gaps between the deck steps should be covered to have less than 4" exposed.

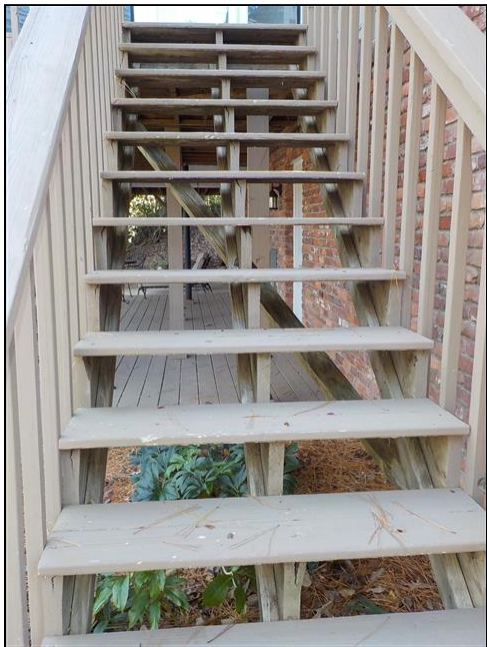
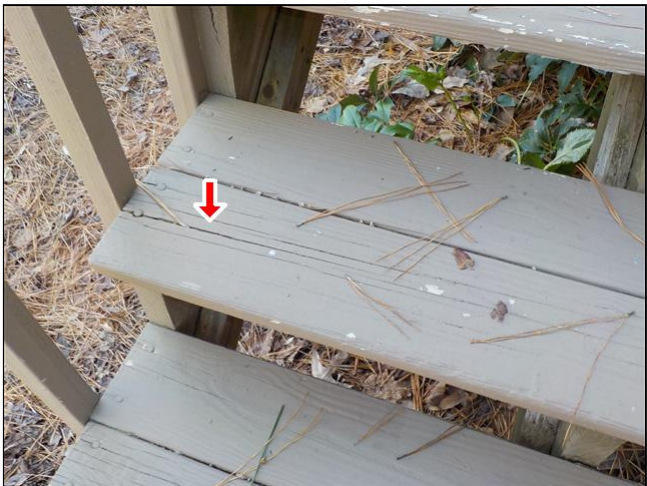
(3) The deck staircase treads are worn with many of the coming loose and cracked. Some of the stringer supports have also cracked. Have these issues further evaluated and repaired by a qualified contractor.

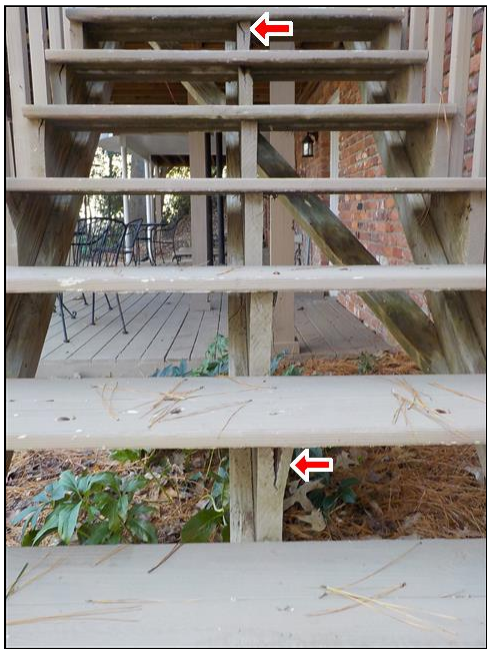
Example, cracks step

Cracked stringer

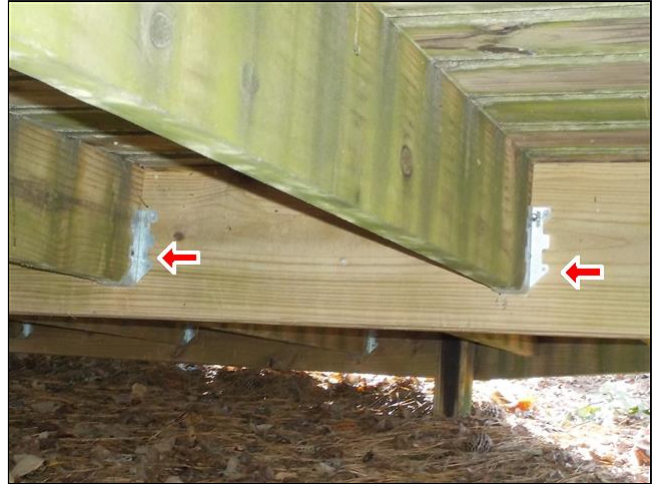
At both of the lower deck platforms (by house and by water), most of the joist hangers are missing one nail. Have the hangers reviewed and repaired as needed.

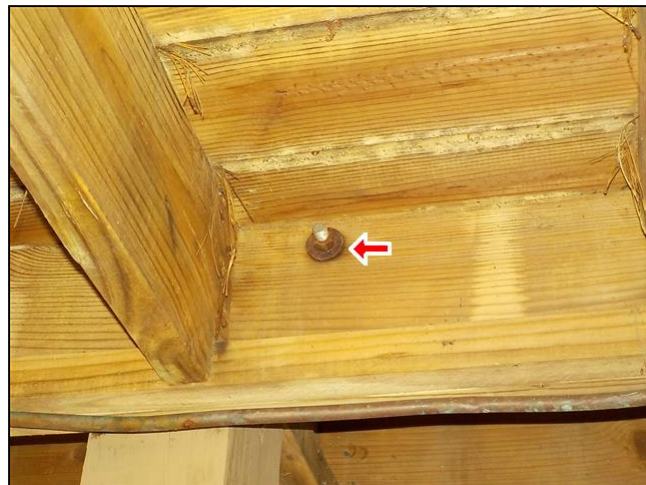
Some of the deck bolts at the ledger boards against the house and elsewhere have rusted. Have the decks further evaluated and repaired as needed by a qualified contractor.

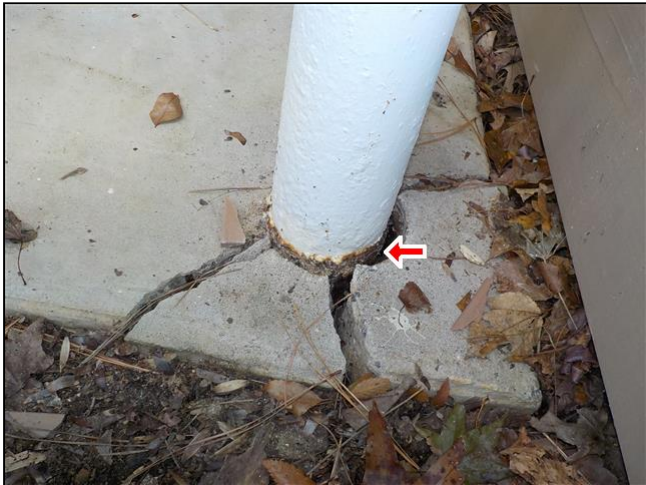
Rust was observed on one of the metal support posts in back.

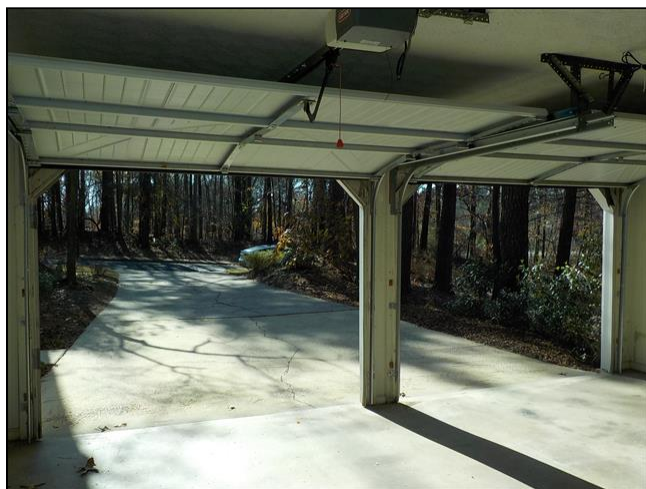
View of overhead doors

- The near side door safety sensors were installed incorrectly, on the ceiling.
- Neither of the overhead doors responded to pressure when closing, which normally should cause them to reverse.

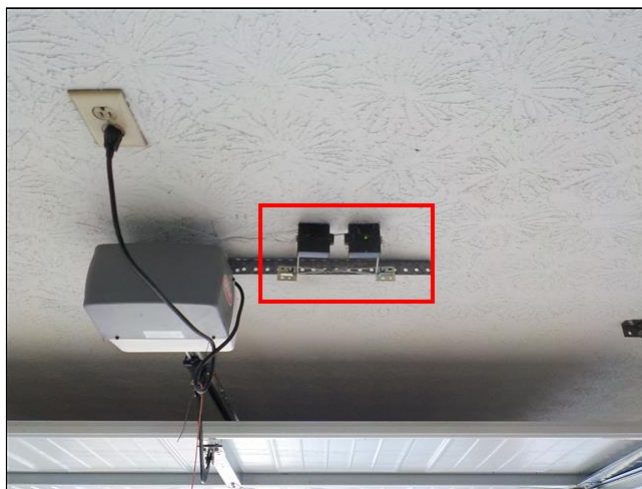
Sensors installed improperly

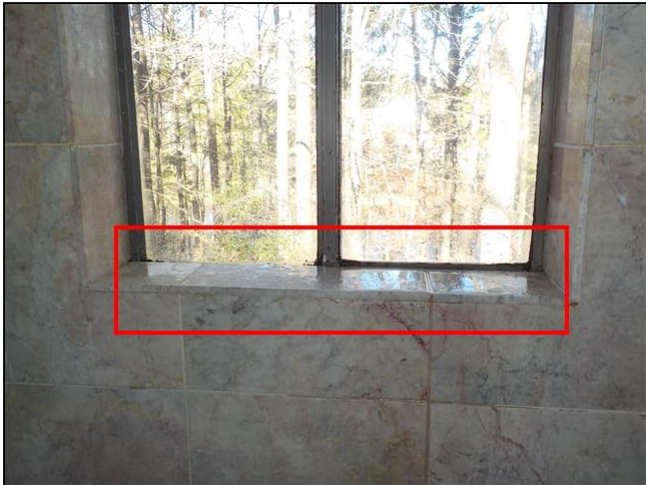
(1) There is an awkward transition at the 2nd floor guest bathroom window where the tile and window meet. This area will need to be well sealed to prevent water infiltration. Have reviewed by a qualified contract to determine what fixed can be done to make this better.

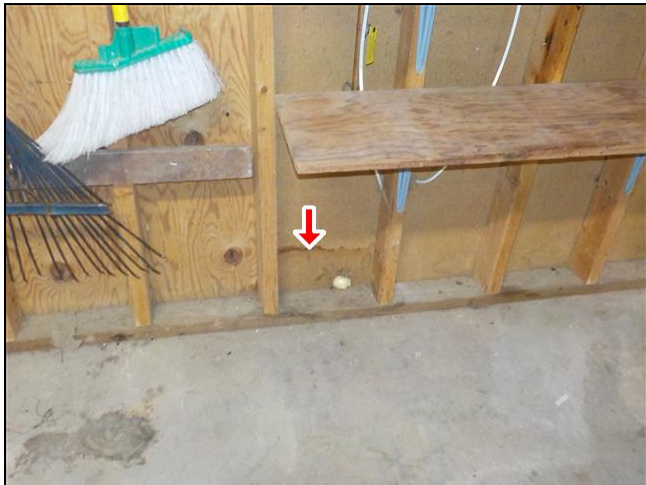
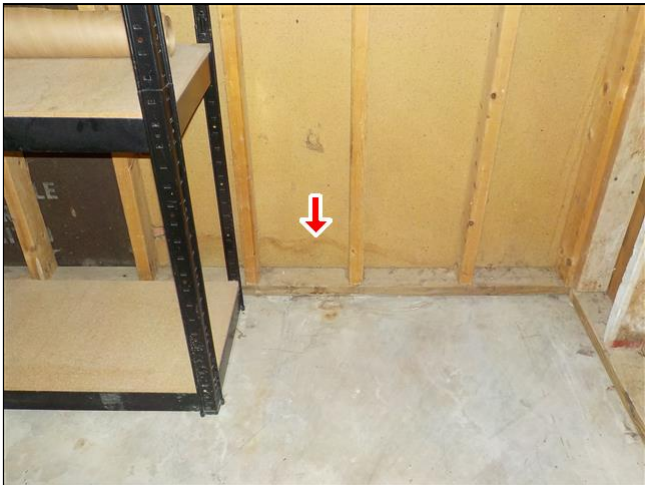
(2) Stains on the wallboard at the exterior wall in the unfinished basement were dry at the time of the inspection and are likely old issues.

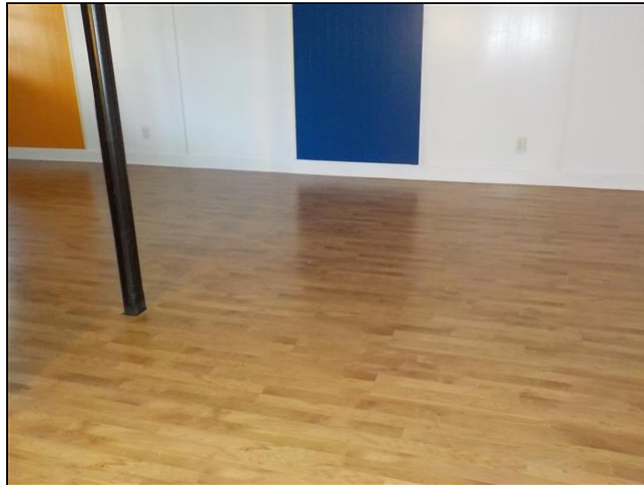
(2) The floor covering in the basement is noisy when walked on, but I am unsure of the cause. It is likely normal. Consult a flooring contractor as needed.

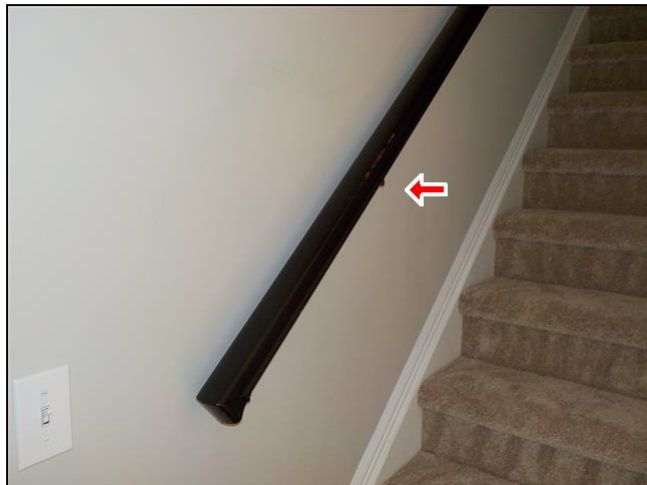
(1) The 2nd floor staircase hand railing is a little loose at the bottom.

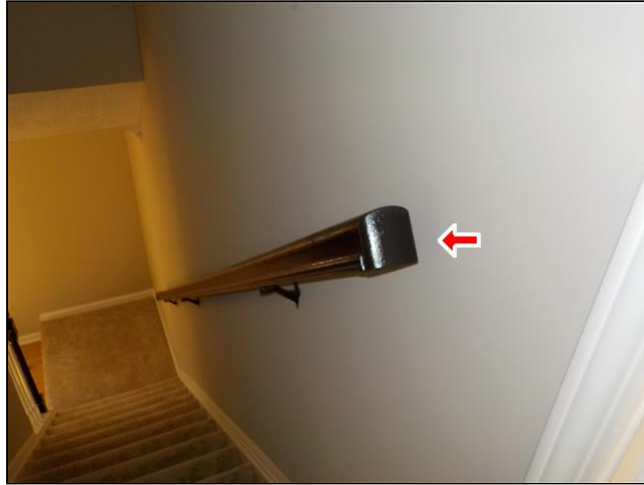
(2) It is recommended to install the 2nd floor staircase hand railing to return back into the wall to prevent snagging from loose clothing.

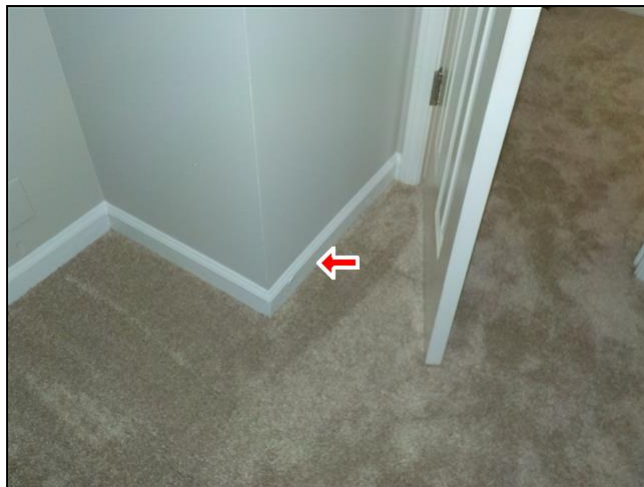
(1) The master closet doorstop is missing.

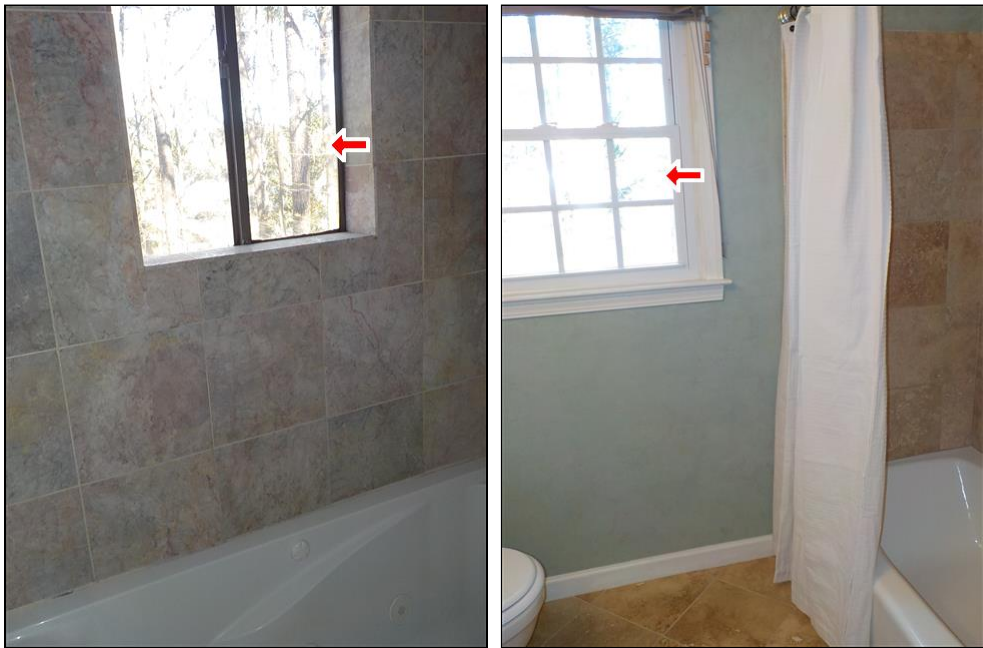
(1) Windows with tempered safety glass are missing in the two 2nd floor bathrooms, and these would help prevent injury in the event someone slips into the windows. This can be accomplished with a specialized window film. Have further evaluated and repaired by a qualified window professional.

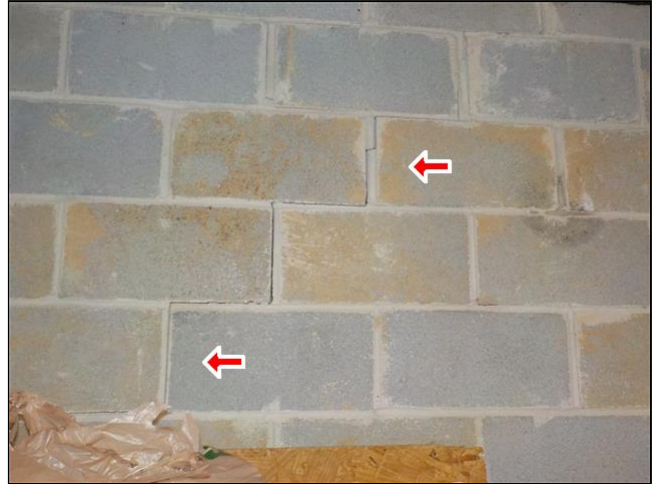
Common settling cracks were observed on the block wall foundation in the unfinished basement area. The cracks should be repointed with mortar and monitored for changes.

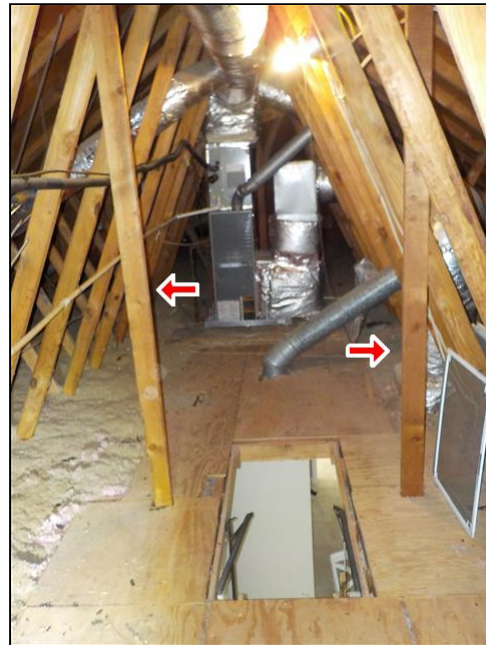
(1) One of the roof trusses in the attic has been modified to accommodate the pull down ladder. Trusses can't be modified without engineering approval and should be further evaluated by a qualified engineer and repaired as needed. There has been some additional framing added but I am unsure of its adequacy.

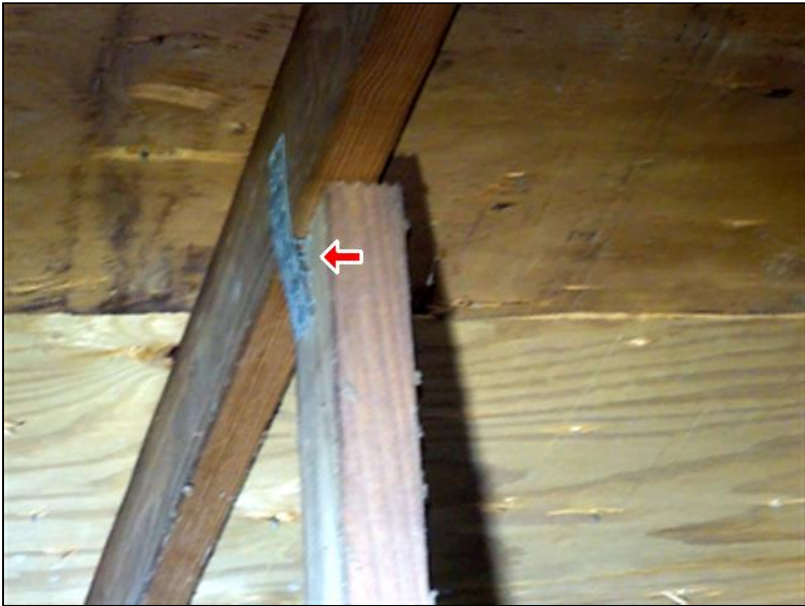
(2) One of the truss plate connectors is loose in the attic to the left of the furnace.

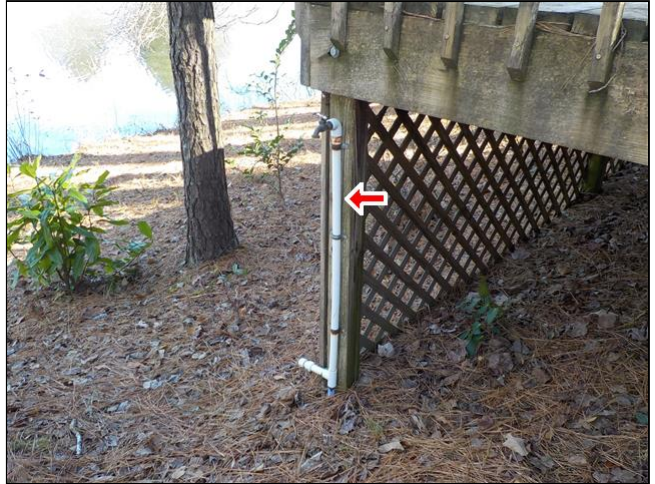
(1) There is a hose attachment in back that I suspect is connected to the piping visible at the deck by the water. This is not tested as part of the inspection. Contact the seller for more info.

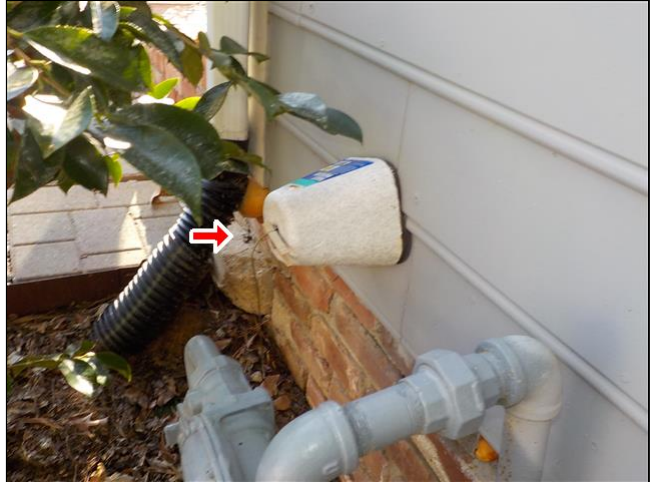
(2) The exterior hose bibbs have been winterized and could not be tested. Contact the seller for more info.

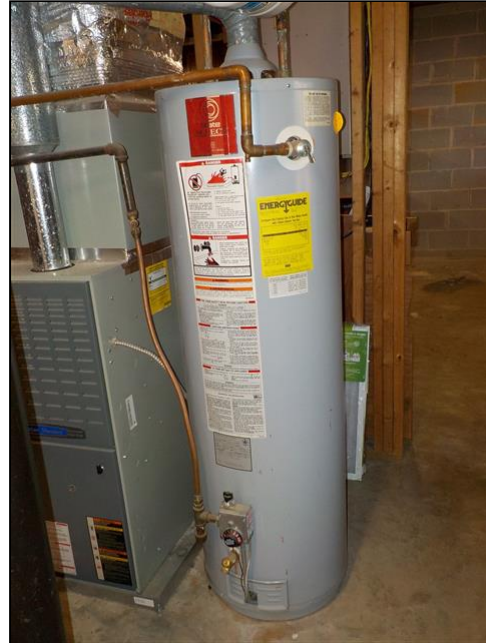
The water heater is 17 years old and beyond the end of its useful life. Given that the basement is partially finished, replacement of the water heater is needed as leaking can cause big problems to the finished space.

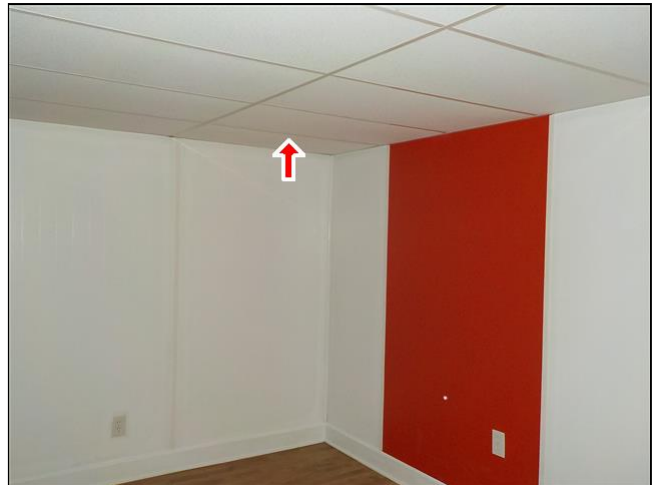
Wide view of where valve is located above ceiling

The main water shut off valve in the basement ceiling leaks when turned and should be further evaluated and repaired by a qualified plumber.

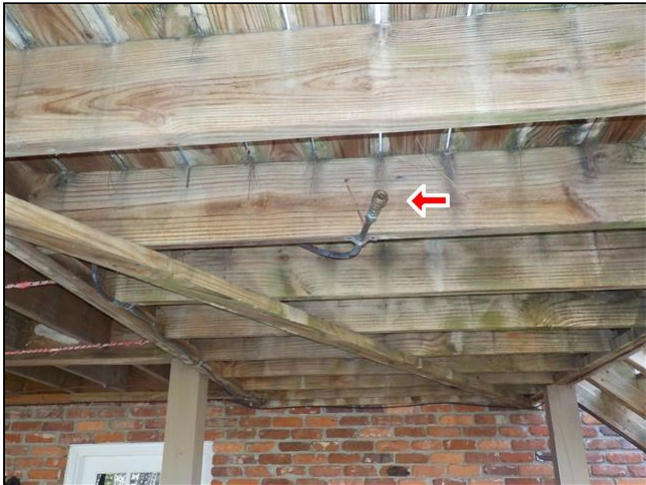
What appears to be a gas line for a grill was observed under the covered back porch but can't be tested during the inspection. Contact the seller for operational info.

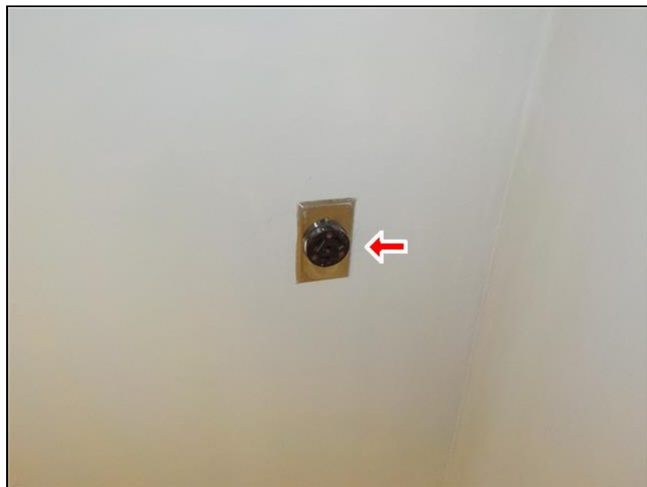
(3) The existing dryer outlet is the old style that will not work with new dryers. However, you can buy a 3-wire cord that works with new dryers. This is informational only.

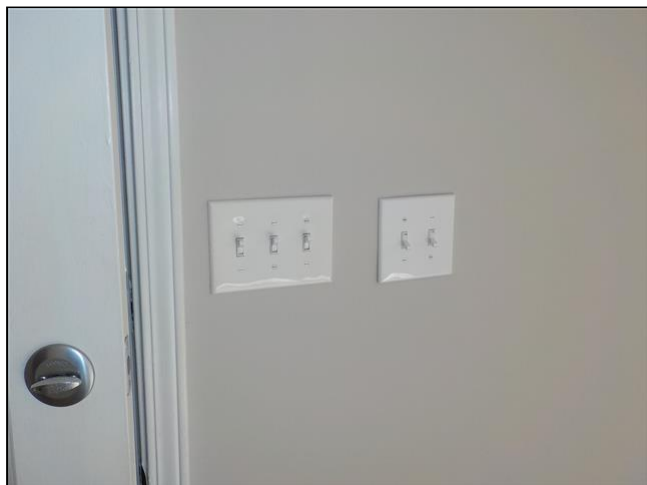
(4) I was unable to determine what all of the wall switches operate in the master bedroom. There is only the need for three switches (light, fan, switched outlets). Also, the light and fan only operate with one switch. Contact the seller for more info or have further evaluated and repaired by a qualified electrician.

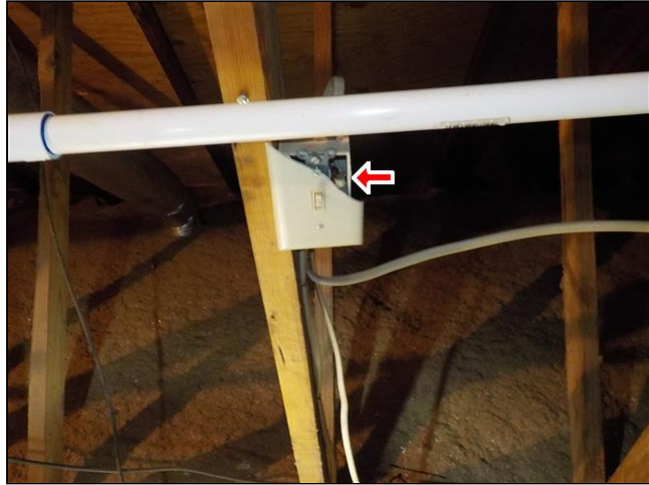
(5) The attic furnace service switch cover is broken.

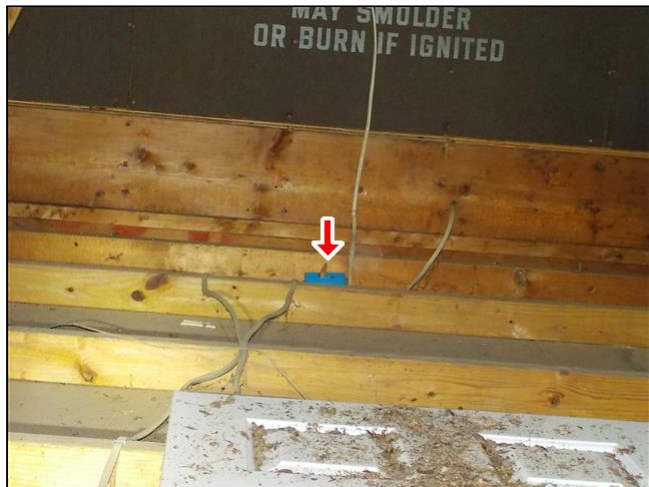
(6) An uncovered junction box was observed in the garage attic.

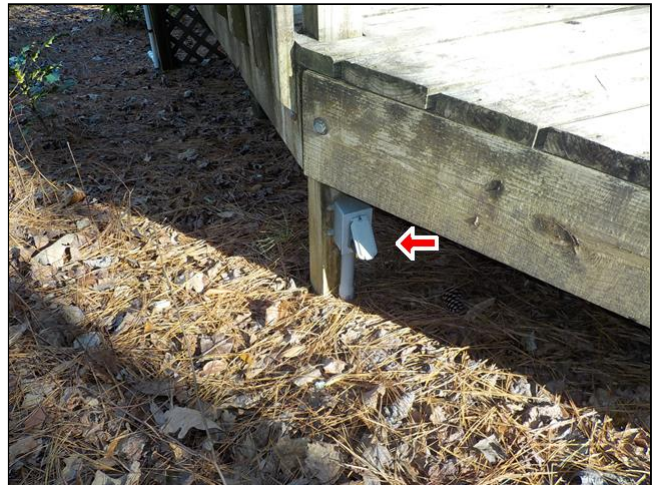
(9) I was unable to determine how to turn on power to the back yard path lighting and the outlet at the deck near the water. Contact the seller for more info.

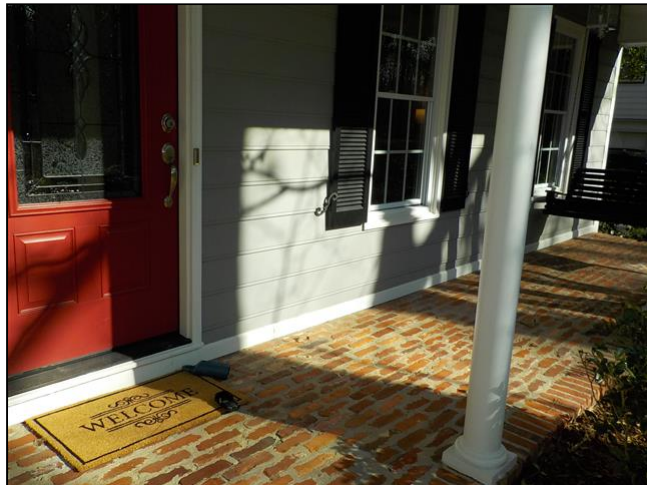
(10) An outlet is recommended at the front porch.

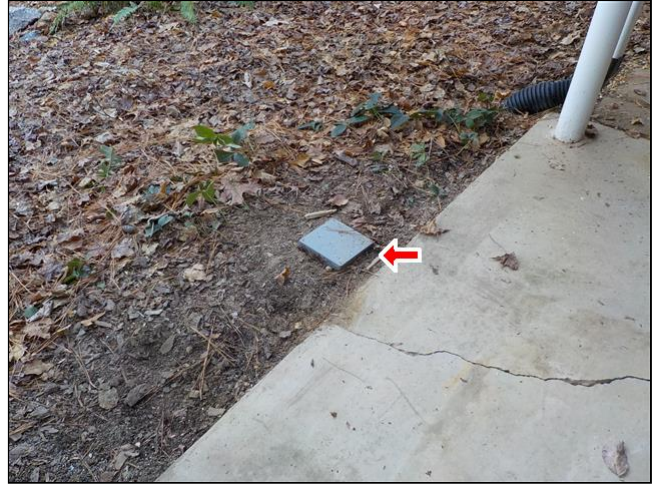
(11) Wiring for a previously installed hot tub was observed in back. This is informational only.

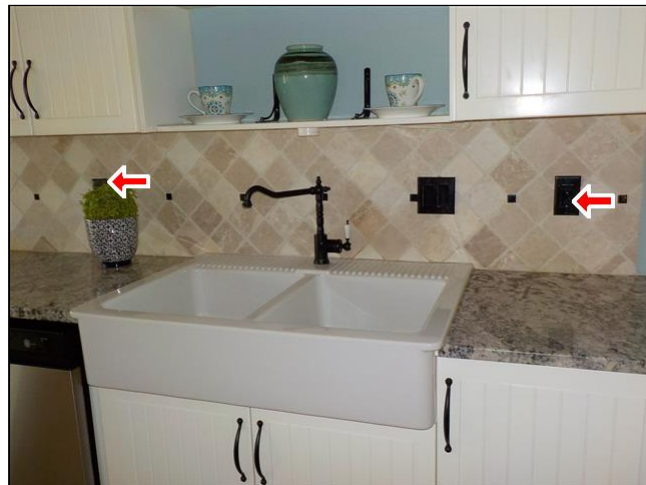
(1) GFCI protection is missing at the outlets by the kitchen sink, creating an unsafe condition.

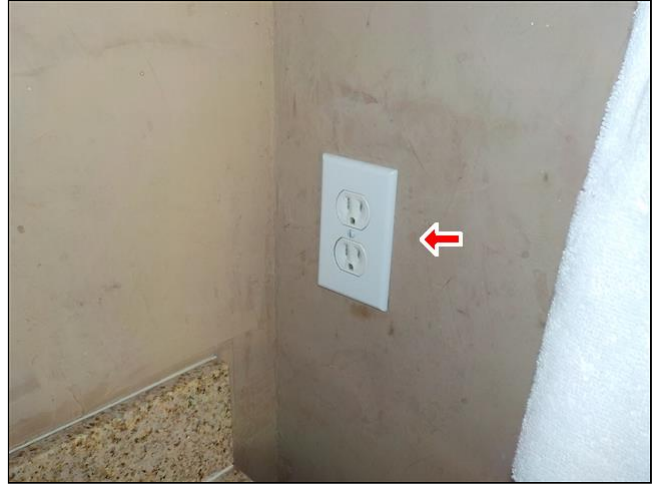
(2) GFCI protection is missing at all of the outlets in the bathrooms, creating an unsafe condition.

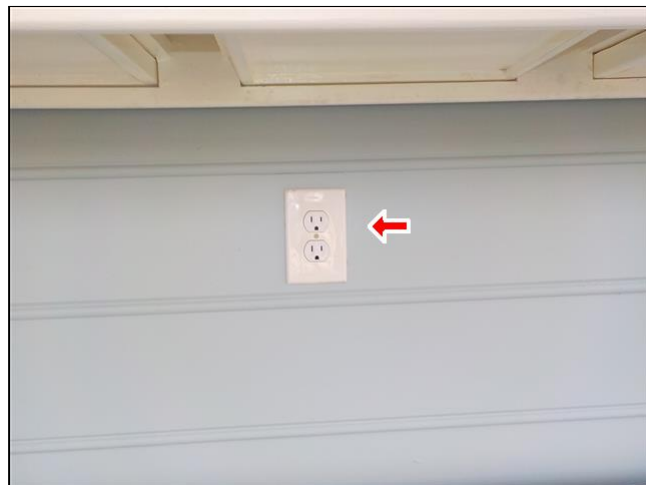
(3) The covered porch outlet is lacking GFCI protection.

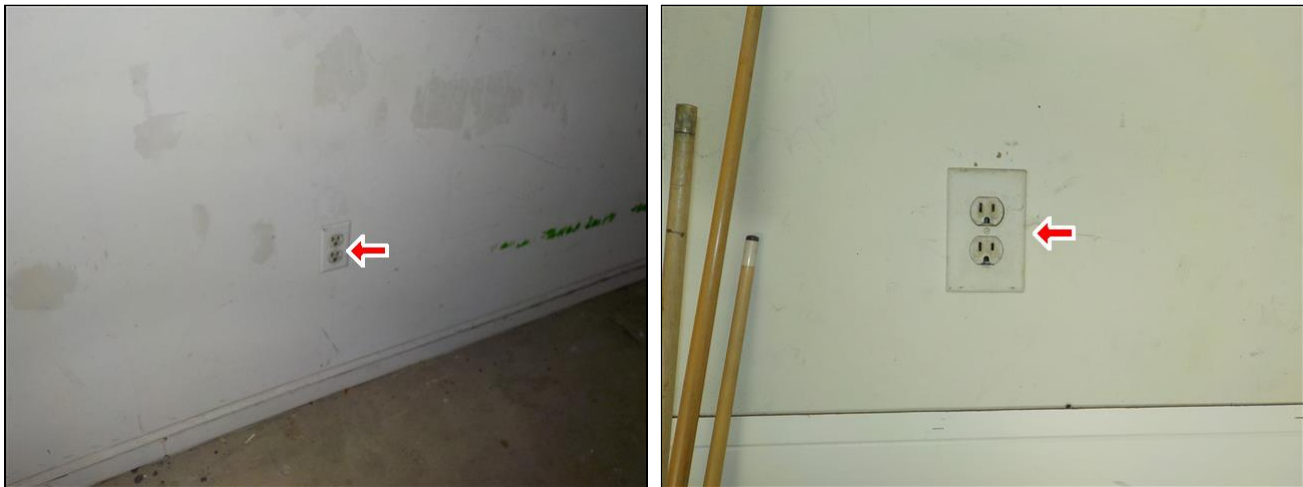
(4) GFCI protection is missing at the garage outlets.

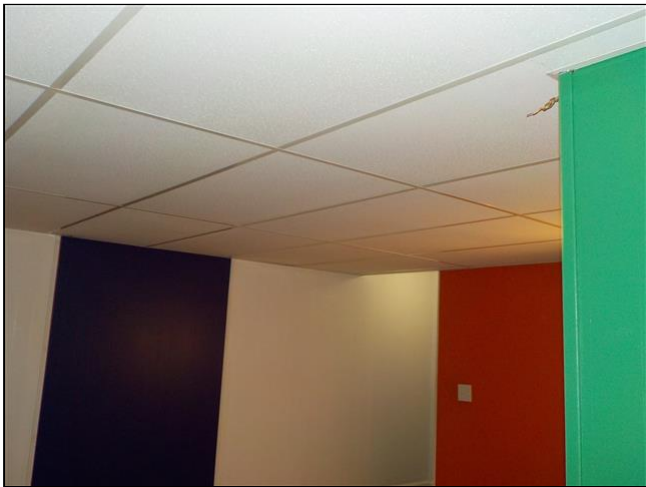
(1) An smoke detector is needed in the finished basement.

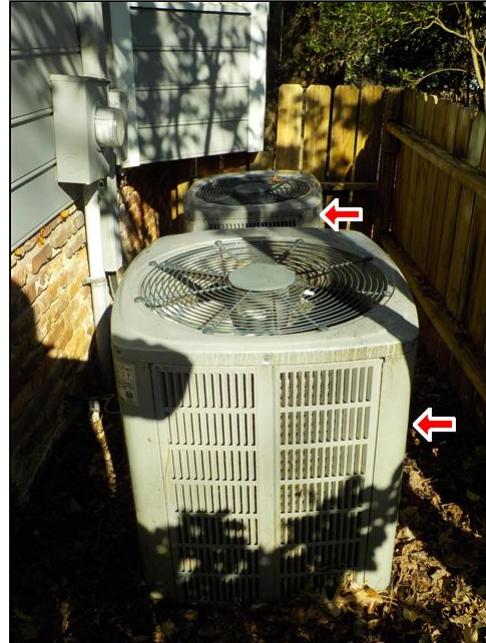
(1) The A/C units are off level which can affect compressor operation, lubrication and places excessive stress on the freon lines and connections. Have leveled by a licensed HVAC professional.
