# Inspection Report

**Property Address:**  
4474 Karls Gate Dr  
Marietta GA 30068

**Dana Inspection Services, Inc.**

<b>Date:</b> 12/21/2020		
<b>Property:</b> 4474 Karls Gate Dr Marietta GA 30068	<b>Customer:</b> Jonathan Bussell	<b>Real Estate Professional:</b> Lisa Collins Atlanta Fine Homes Sotheby's International Realty - Atlanta

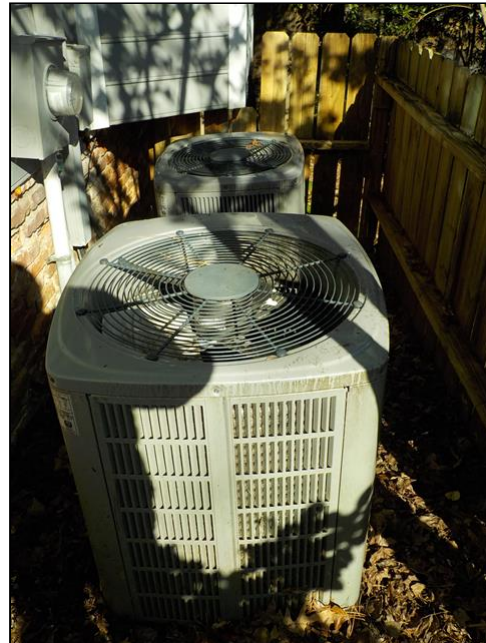
(2) Due to the cold outside temperature, the cooling systems could not be tested. It is recommended to have the seller provide a home warranty to cover any issues that might arise in the 1st year. The units are 12 years old and nearing the end of their useful lives.

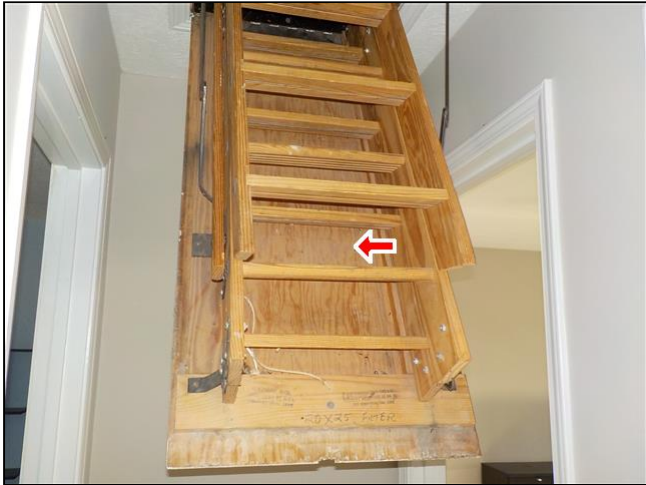
Insulation and weather stripping should be added to the attic pulldown ladder or the attic opening should be insulated with a cover.

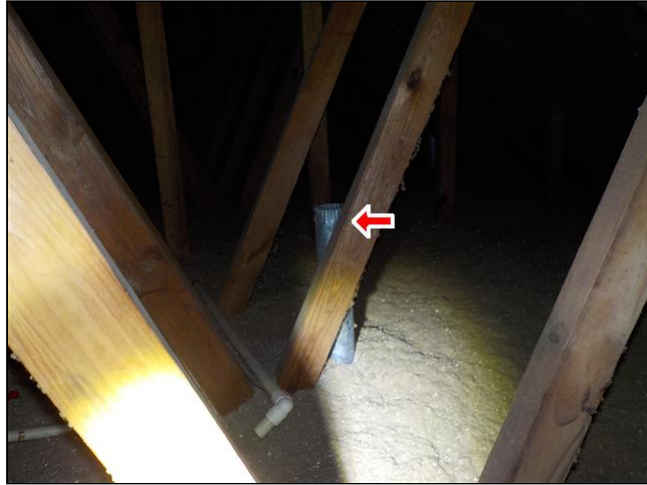
Bathroom vent fans are terminating inside the attic and should be repaired to terminate to the exterior.

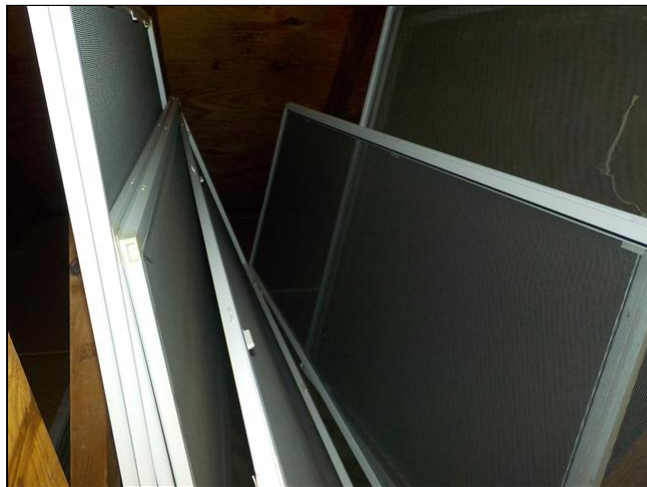
Window screens are present in the garage attic. This is informational only.

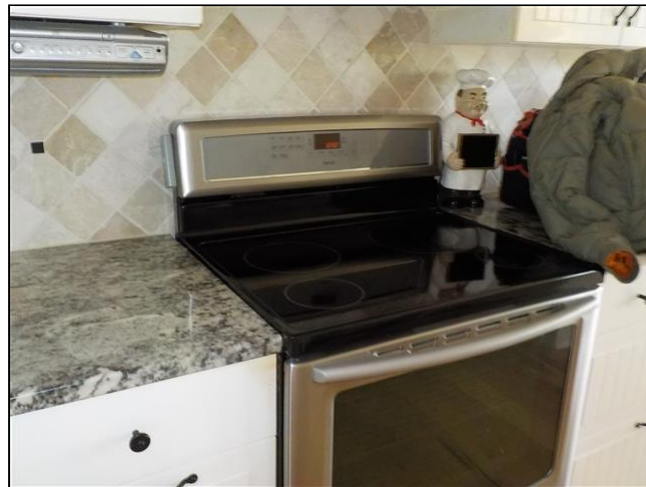
(1) An anti-tip bracket is missing or not engaging behind the oven that would prevent the unit from accidentally falling over should pressure be applied to the open door.

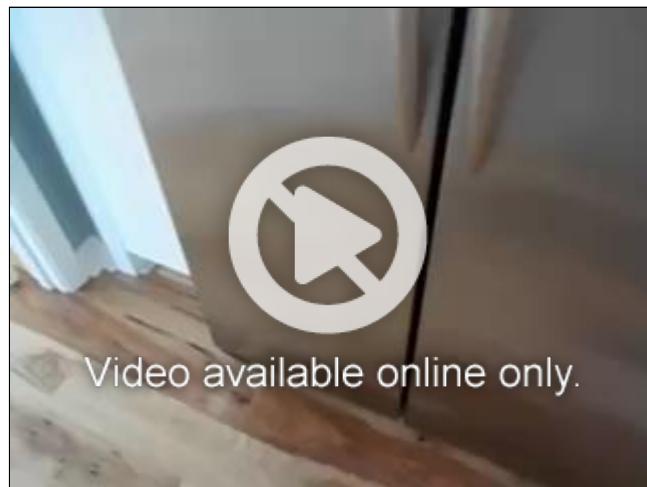
(1) The refrigerator left hand door hinge makes a knocking sound when the door is opened and closed.

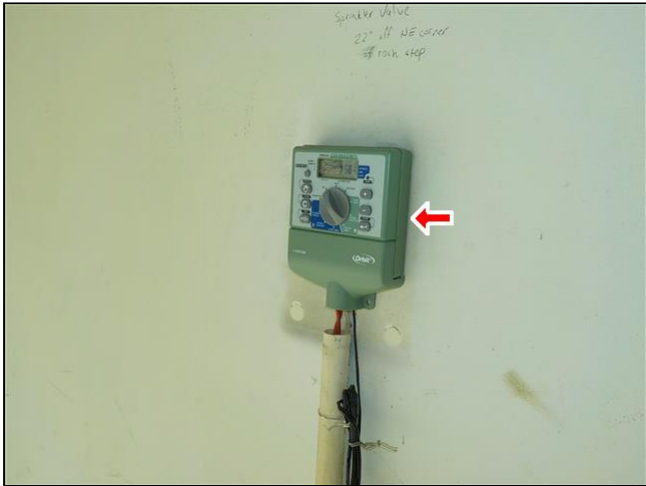
A irrigation system control panel was observed in the garage but is a specialized component that was not tested. Contact the seller to provide information on how it operates or have evaluated by a qualified irrigation professional.
