# Inspection Report

**Property Address:**  
4474 Karls Gate Dr  
Marietta GA 30068

**Dana Inspection Services, Inc.**

<b>Date:</b> 12/21/2020		
<b>Property:</b> 4474 Karls Gate Dr Marietta GA 30068	<b>Customer:</b> Jonathan Bussell	<b>Real Estate Professional:</b> Lisa Collins Atlanta Fine Homes Sotheby's International Realty - Atlanta

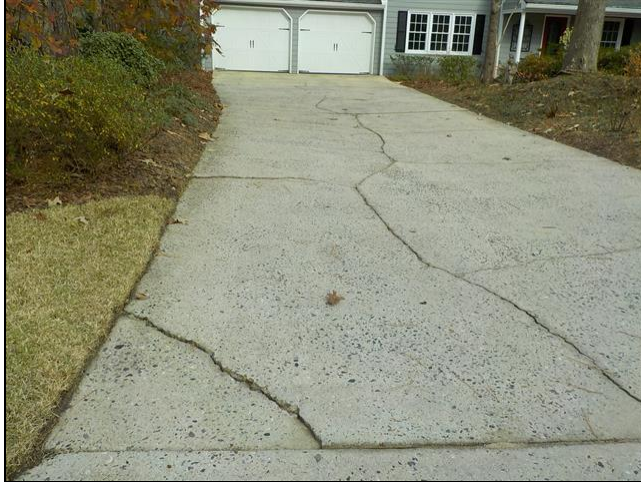
(1) Many cracks were found on the driveway, as well as some settling causing displacement. This is most pronounced in front of the left hand garage opening where a moderate lip is present. Have the driveway further evaluated and repaired as needed by a qualified driveway professional.

Lip at garage entrance

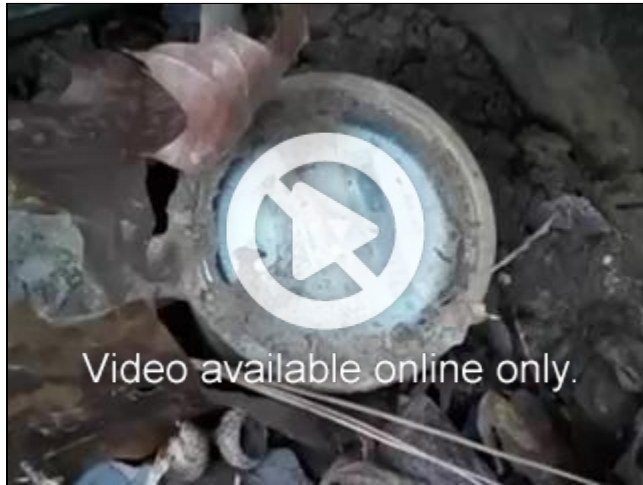
The water meter still showed as having a draw (triangle spinning) even when the main water shut off valve inside the basement was turned off. This may indicate a break in the main water supply line in the front yard and should be further evaluated and repaired by a qualified plumber.

Video of triangle spinning

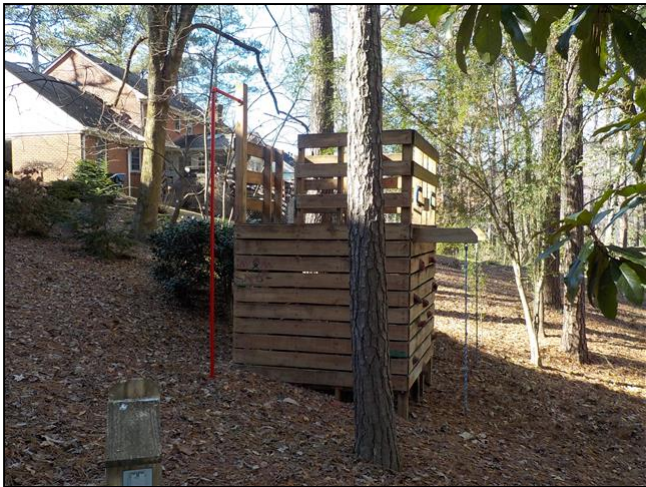
The play equipment in back is beyond the scope of the inspection. This is informational only.

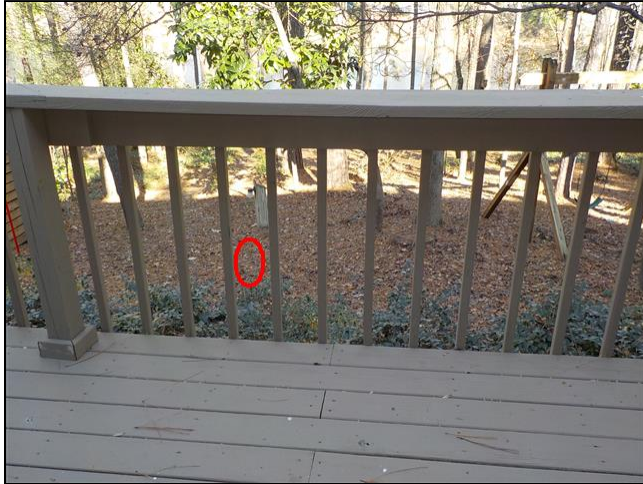
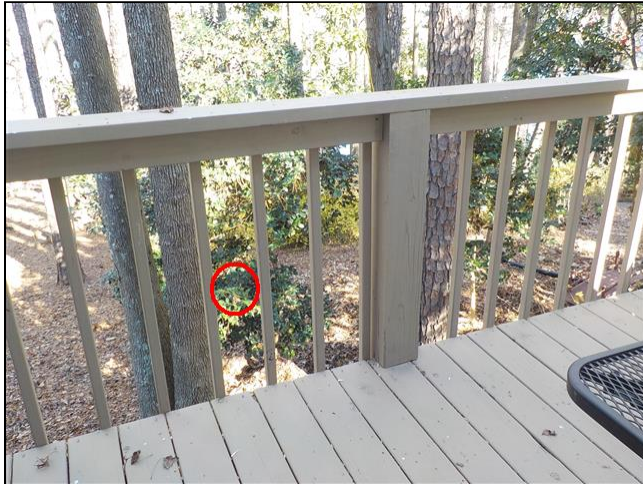
(1) At all of the decks, the balusters are spaced over 4" apart, which is considered a safety hazard by today's standards.

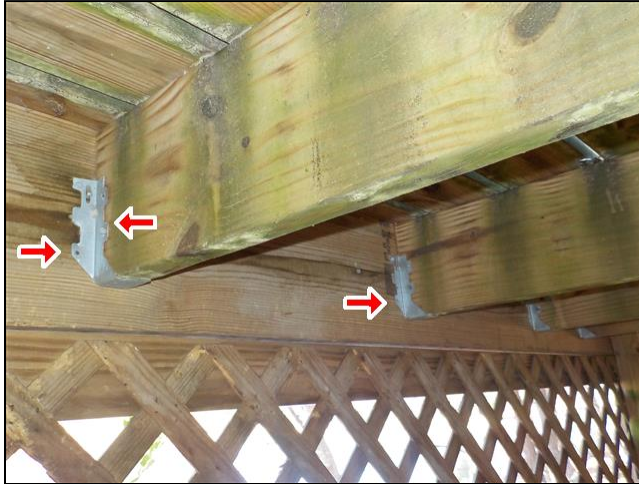
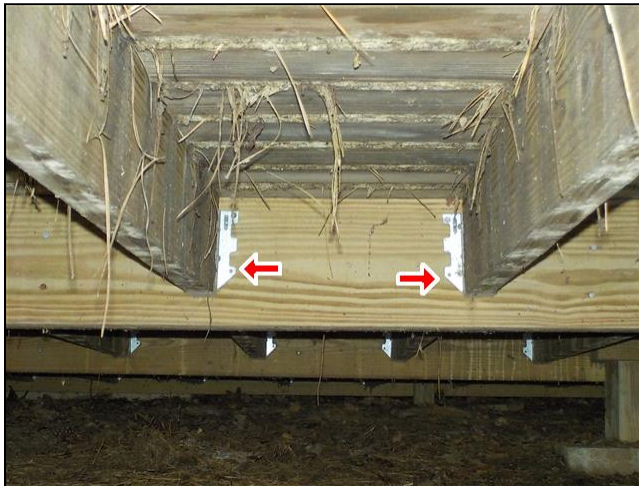
At both of the lower deck platforms (by house and by water), most of the joist hangers are missing one nail. Have the hangers reviewed and repaired as needed.

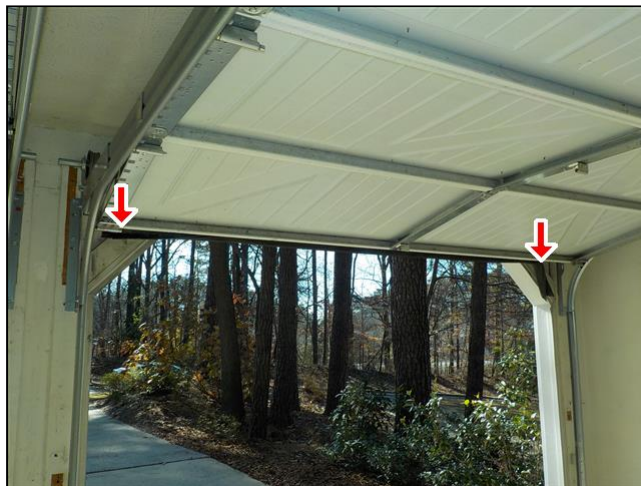
(2) Weather stripping is loose at the far overhead door.

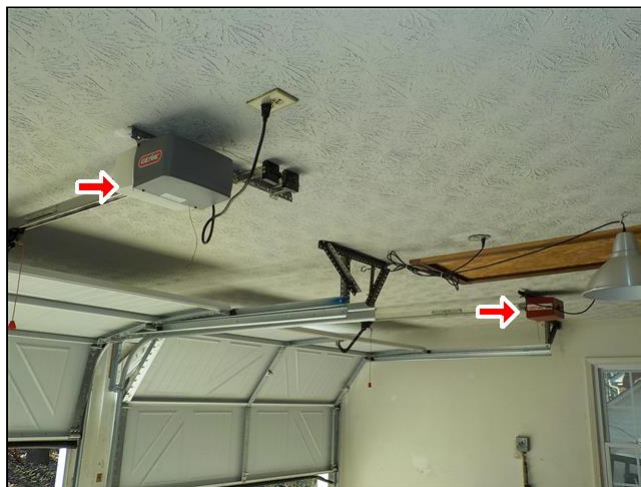
(3) Bulbs and/or covers are missing at the two overhead garage door motor areas.

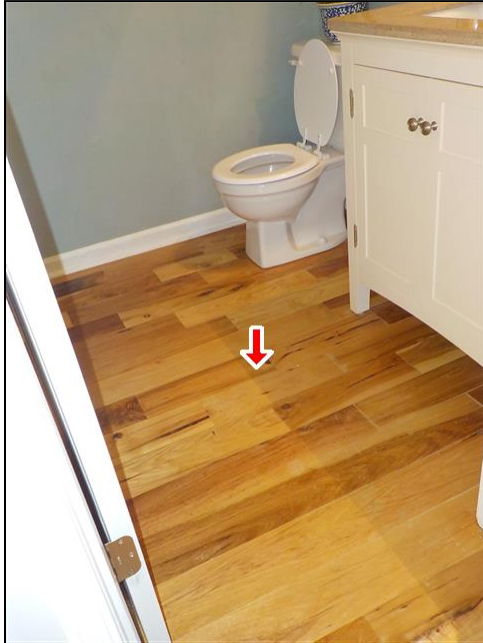
Example area, half bath

(1) Squeaking flooring was heard in several locations on the 1st and 2nd floors. Not all areas of squeaking will be identified by the inspection. Have the flooring further evaluated and repaired as needed.

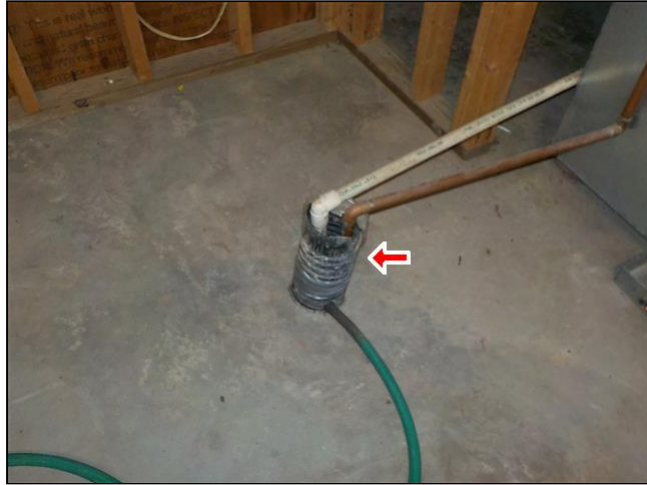
(3) Contact the seller to find out where the unfinished basement floor drain terminates.

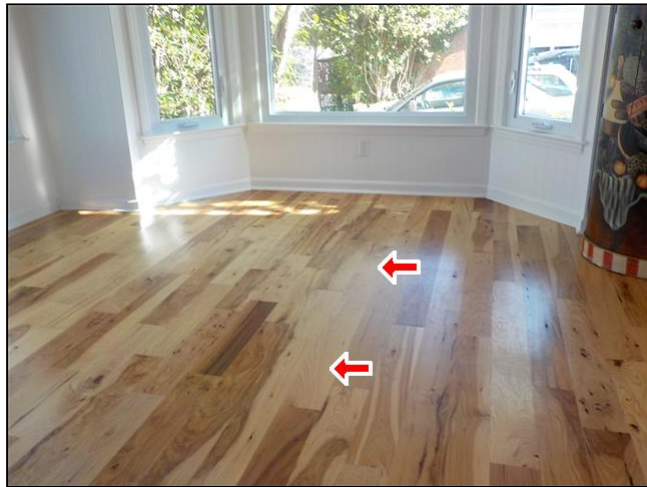
(4) A slight hump was detected in the floor inside the dining area.

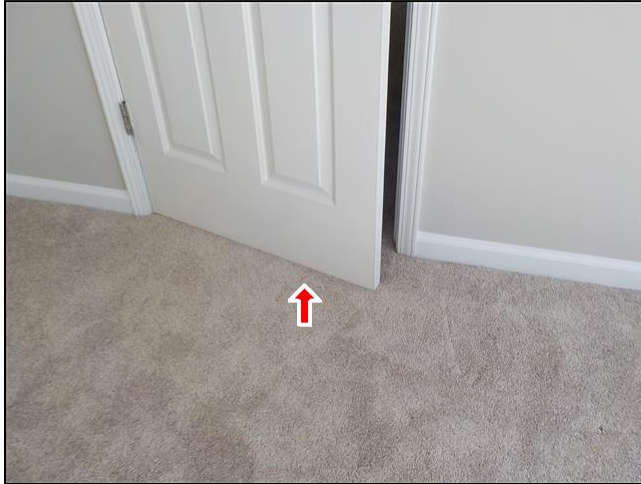
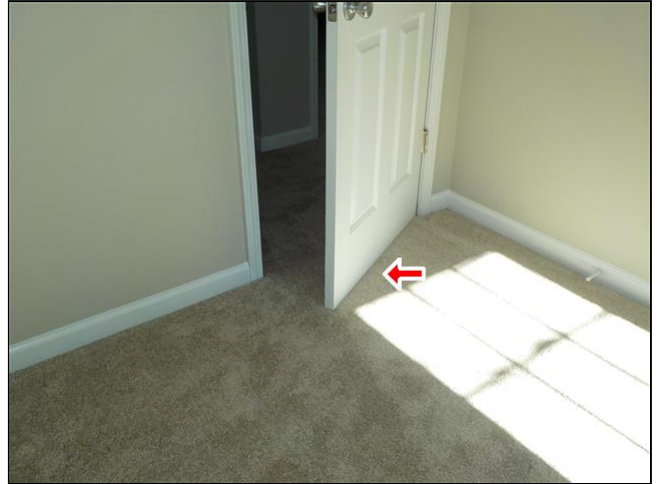
(2) The master bedroom entrance door rubs tightly on the carpeting, as does the 2nd floor front middle guest bedroom entrance door.

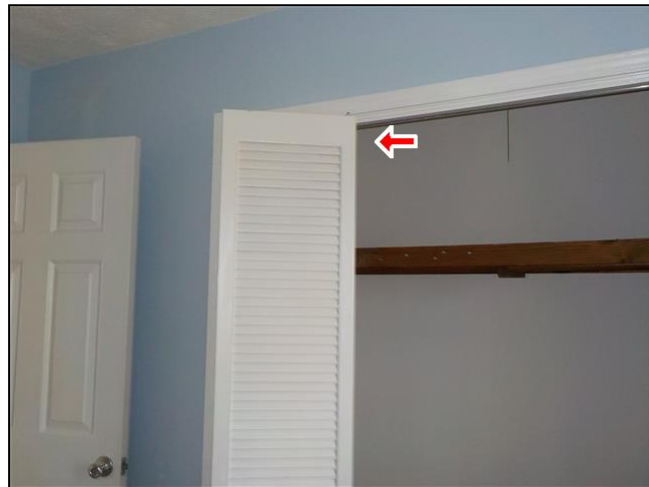
(3) One of the closet folding doors is off the tracks in the 2nd floor blue guest bedroom.

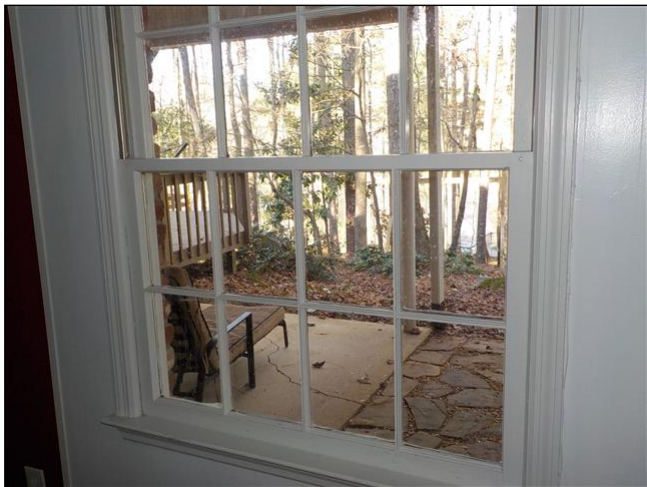
(2) The basement window is still the original single-paned style and should be updated.

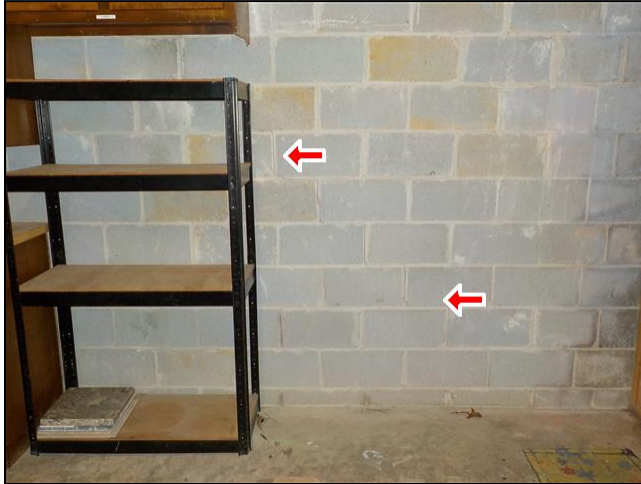
Common settling cracks were observed on the block wall foundation in the unfinished basement area. The cracks should be repointed with mortar and monitored for changes.

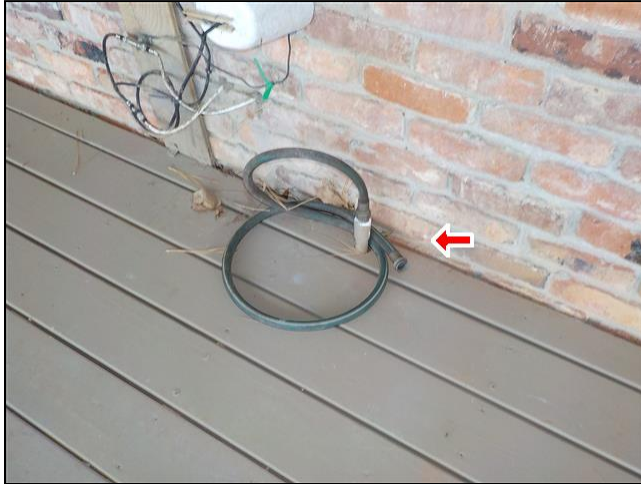
(1) There is a hose attachment in back that I suspect is connected to the piping visible at the deck by the water. This is not tested as part of the inspection. Contact the seller for more info.

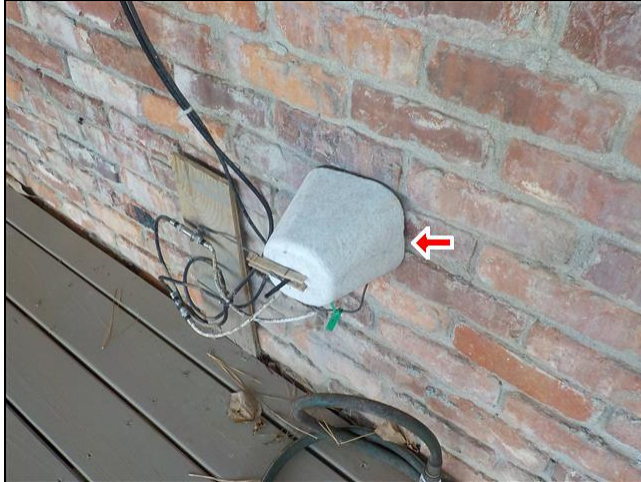
(2) The exterior hose bibbs have been winterized and could not be tested. Contact the seller for more info.

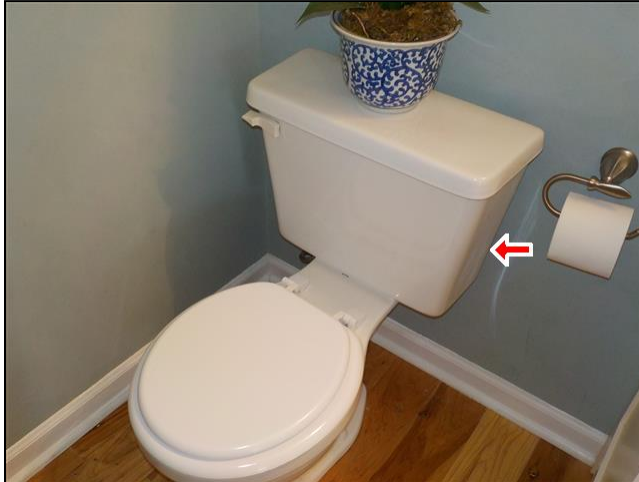
(3) All of the original toilets are still installed in the house, and it is recommended to replace them with new units that use a lot less water.

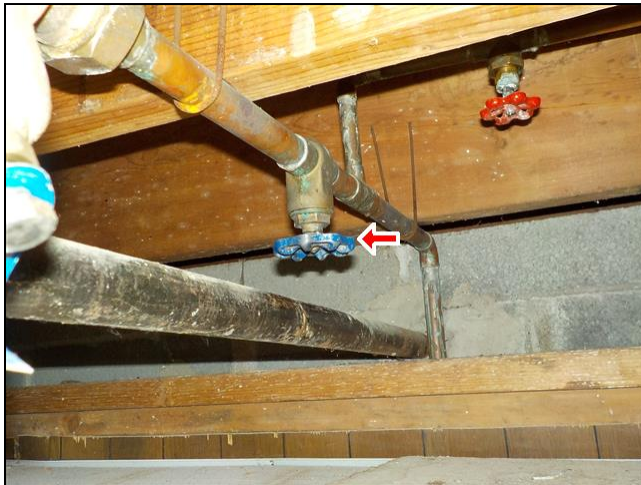
The main water shut off valve in the basement ceiling leaks when turned and should be further evaluated and repaired by a qualified plumber.

Wide view of where valve is located above ceiling

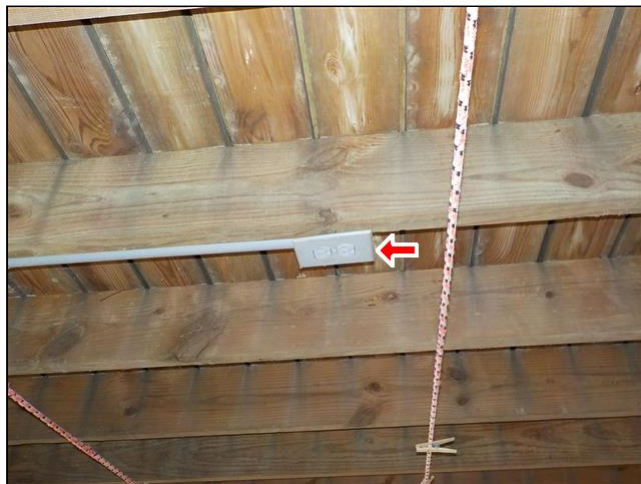
- (1) The outlet in the ceiling under the covered back porch is missing an exterior cover.

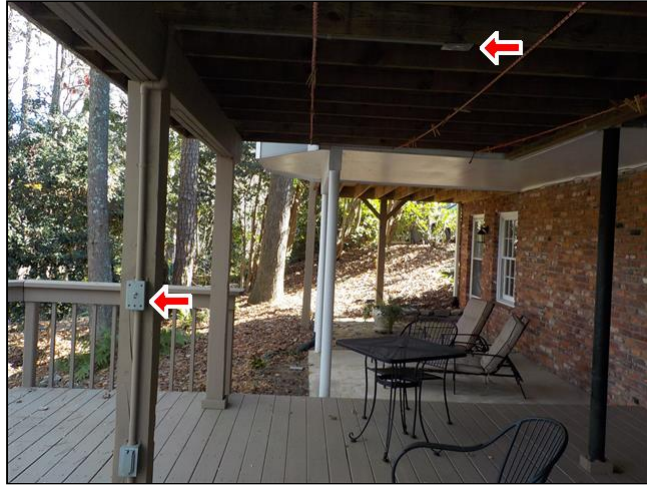
(2) The outlet in the ceiling under the covered back porch is powered by the nearby switch. This is informational only.

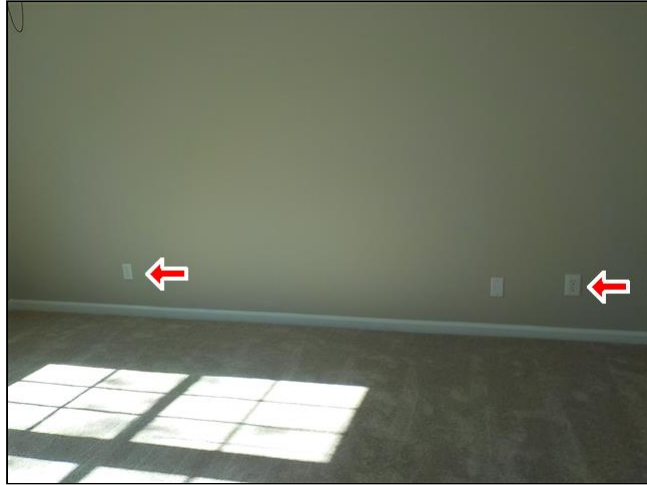
Example area, master bedroom

(8) Several outlets in the rooms around the house are called "switched" outlets, where one of the receptacles has power that is controlled by a wall switch. These are typically used for floor or desk lamps. This is informational only.

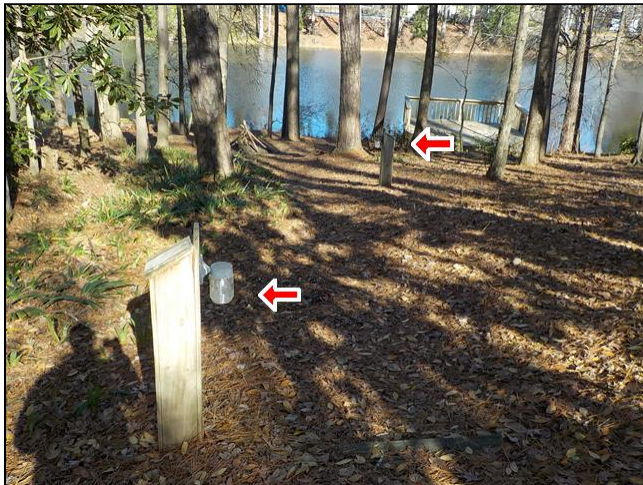
(9) I was unable to determine how to turn on power to the back yard path lighting and the outlet at the deck near the water. Contact the seller for more info.

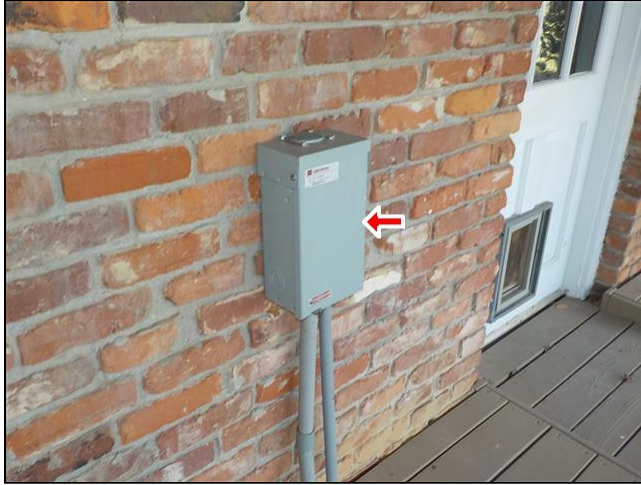
(11) Wiring for a previously installed hot tub was observed in back. This is informational only.

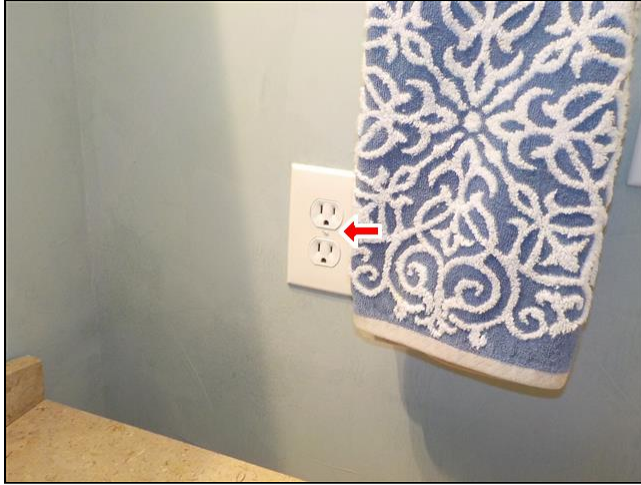
(2) GFCI protection is missing at all of the outlets in the bathrooms, creating an unsafe condition.

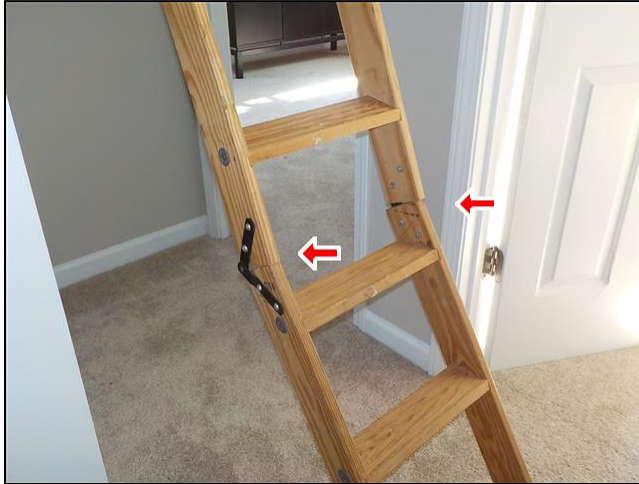
The attic ladder is in a poor and unsafe condition and is in need of replacement. It is also difficult to climb up and down due to the bent arms.

Over extends at joints.

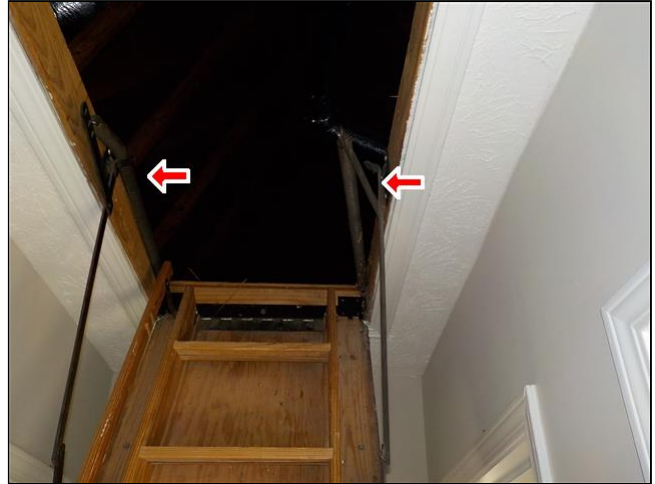
Bent arms

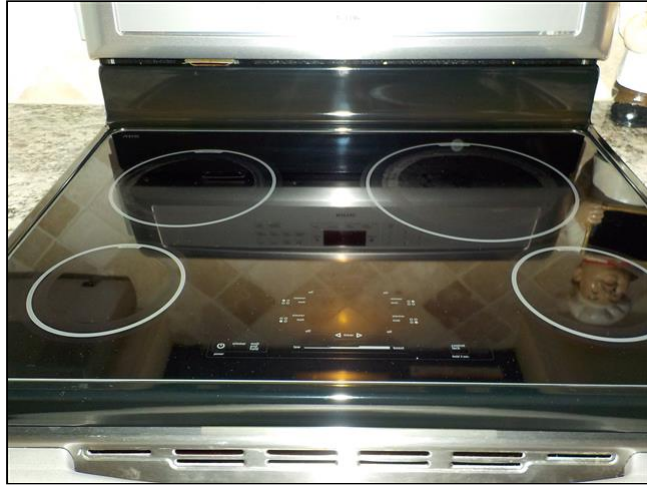
(2) The cooktop is an induction style that only operates with induction specific pans. So I was unable to confirm operation although I suspect it will work fine.

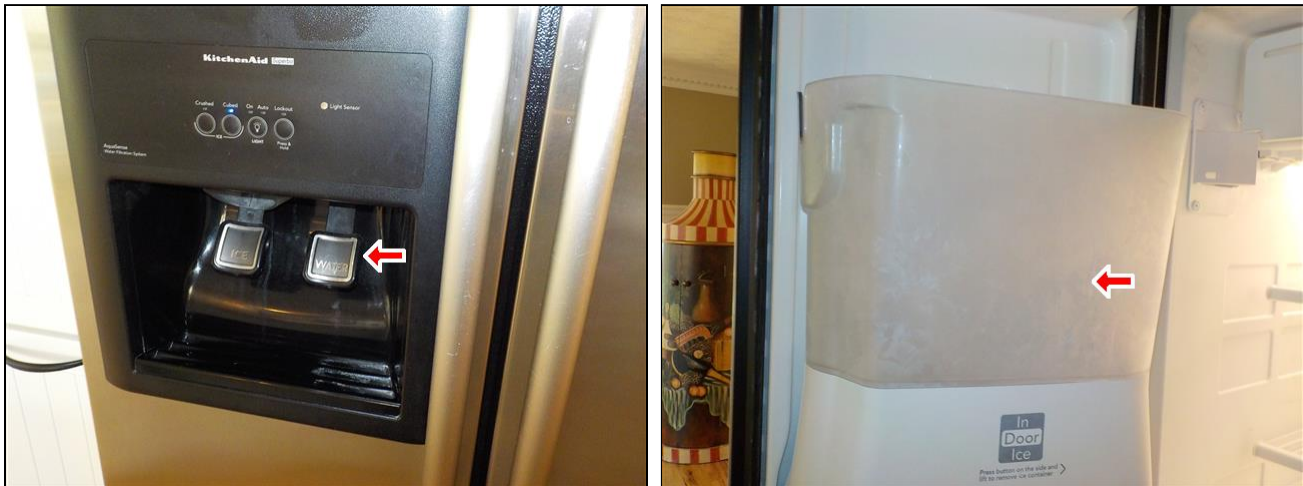
(2) The water supply to the fridge appeared to be off as there was no water flow at the dispenser or ice in the icemaker. Contact the seller for more info.
